# Ecobeach

Results of the test at Egmond  
2007 to 2011

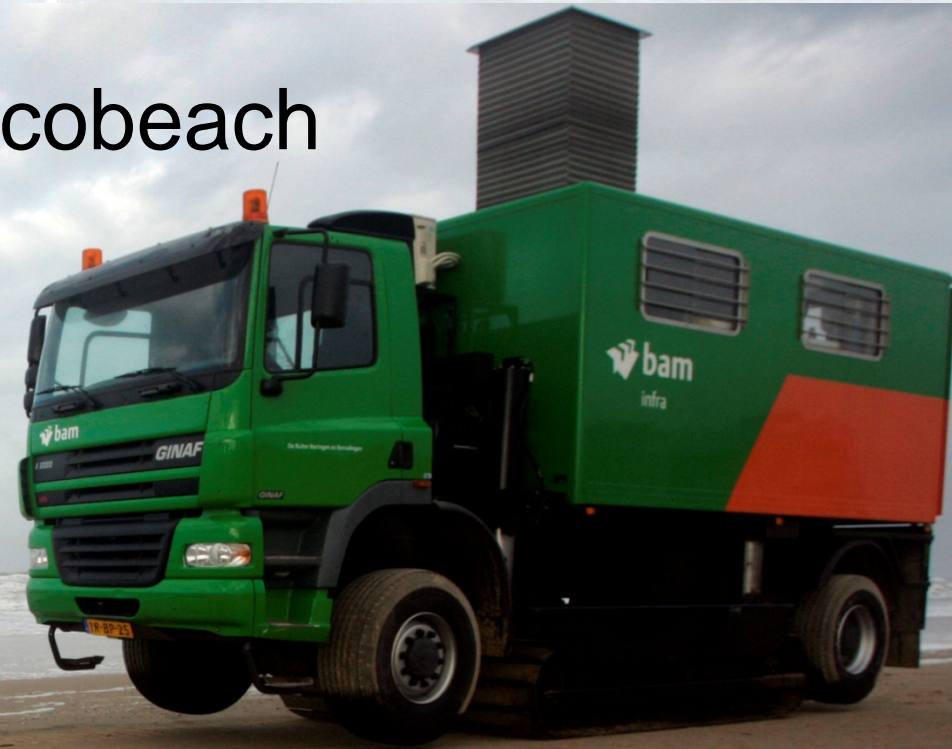
- Ecobeach is vertical beach drainage
- Shore perpendicular rows of drainage tubes
- 10 m cross shore distance
- 100 m longshore distance
- Between dune foot and Low Water Level

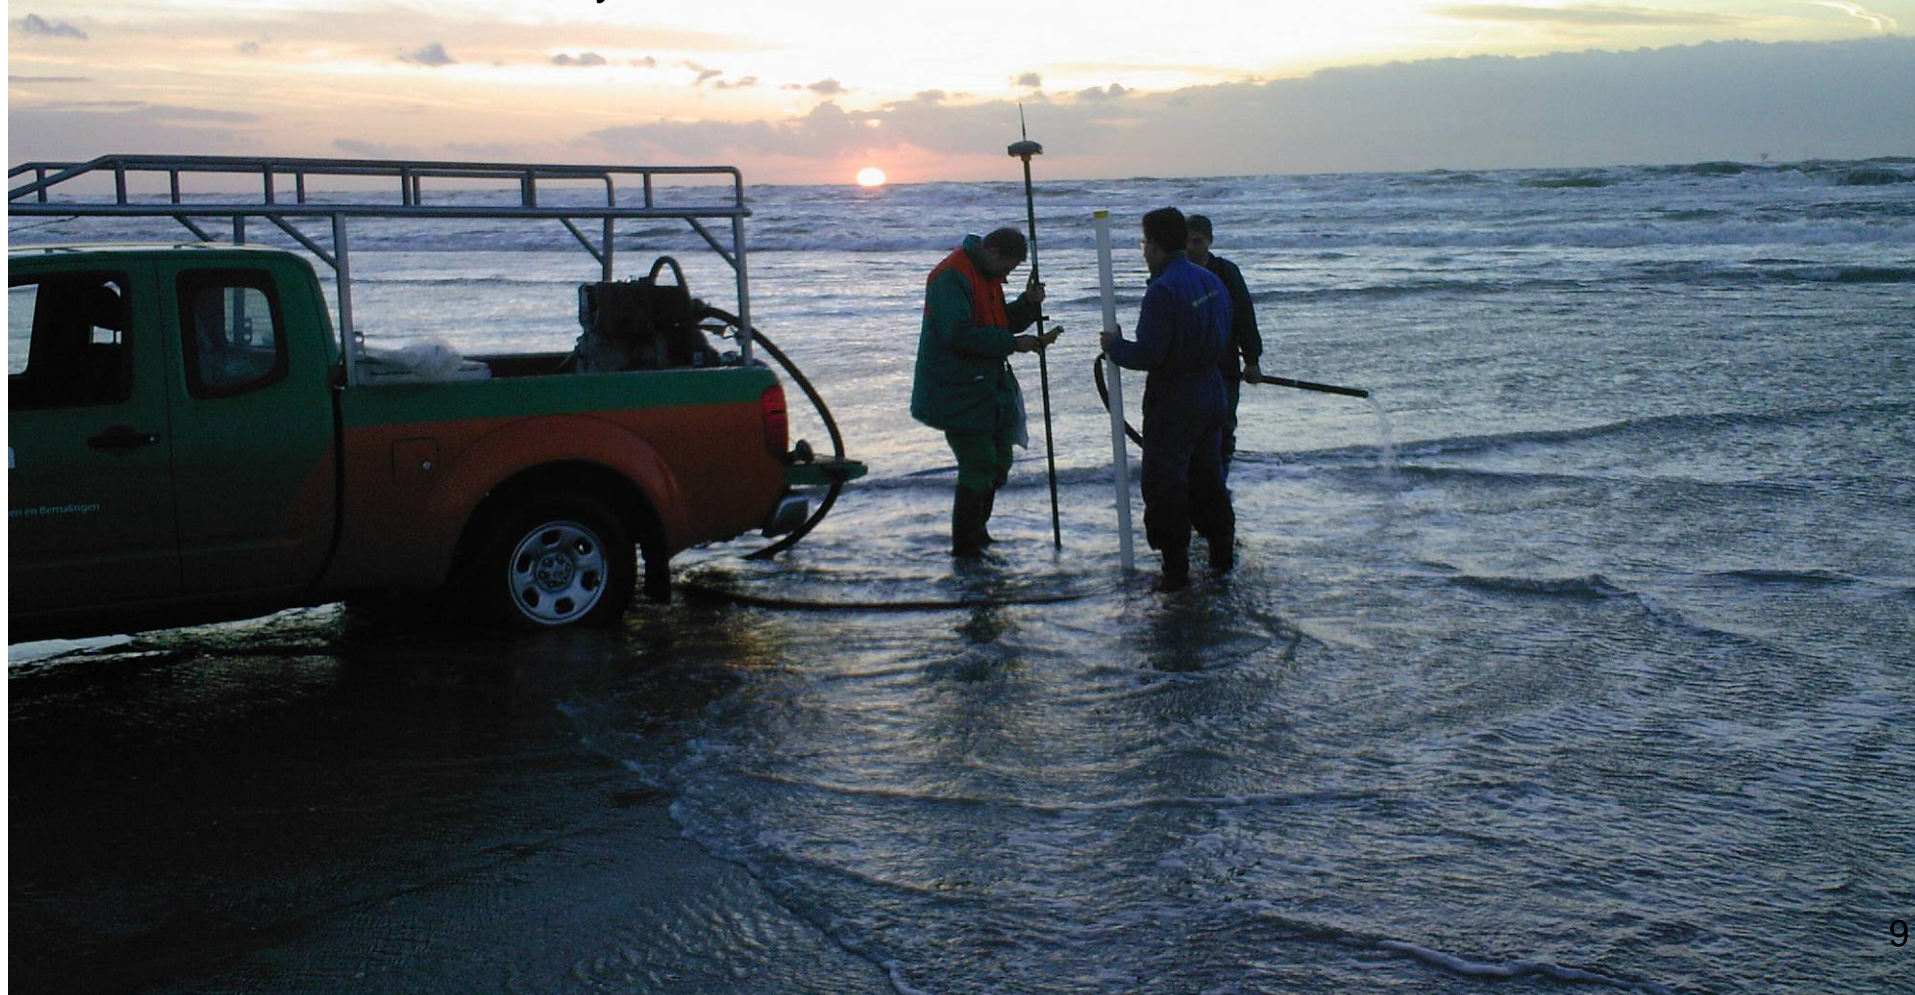
- Two test locations
- Each 3 km long
- Northern site heavily nourished
- Southern site relatively undisturbed
- 1 km in between without Ecobeach
- Argus observation of both areas

- Installation Ecobeach from November 2006 to February 2007
- Installation in test area South completed in February 2007
- Removal of Ecobeach from November 2010 to February 2011
- Removal in test area South completed in February 2011
- Total test duration four years

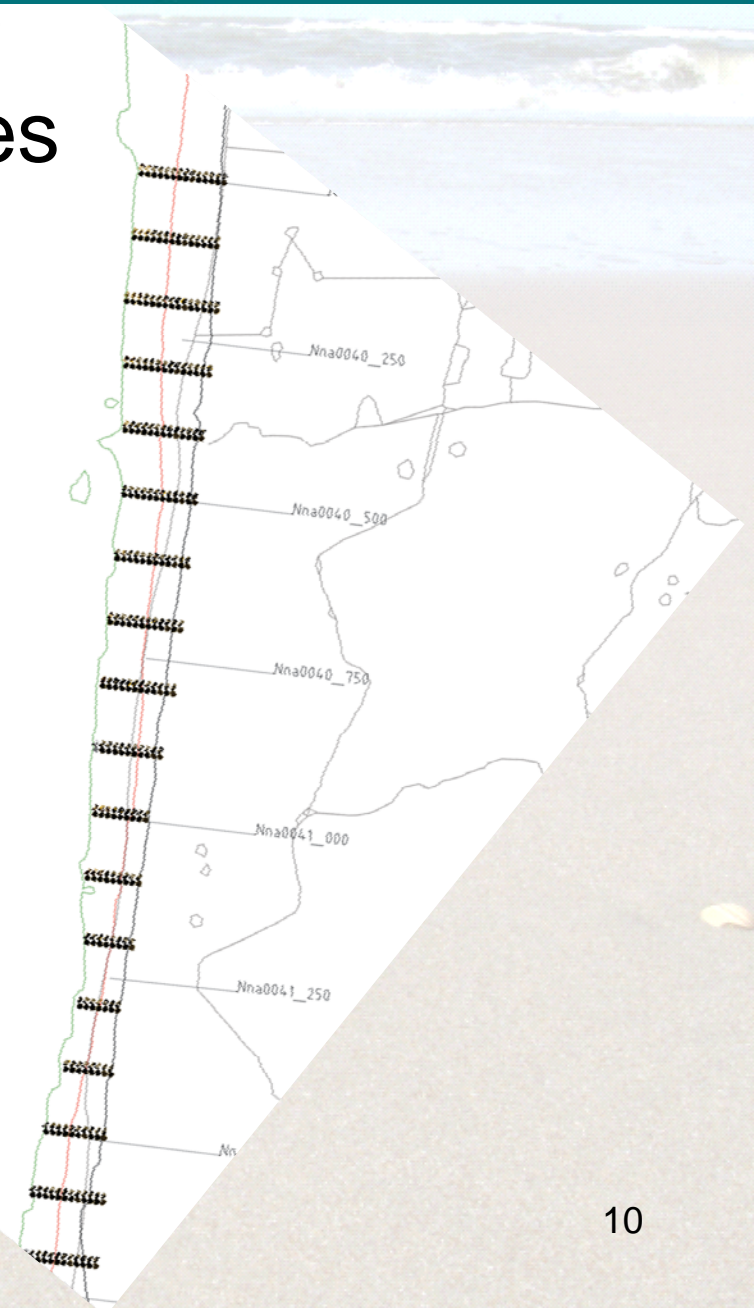
- Number of tubes in a row varies from 6 to 14
- Drainage tubes up to Low Water Line at time of installation
- No tubes have been added during test
- Drainage tubes 1.75 m long
- Installed 0.25 m below seabed

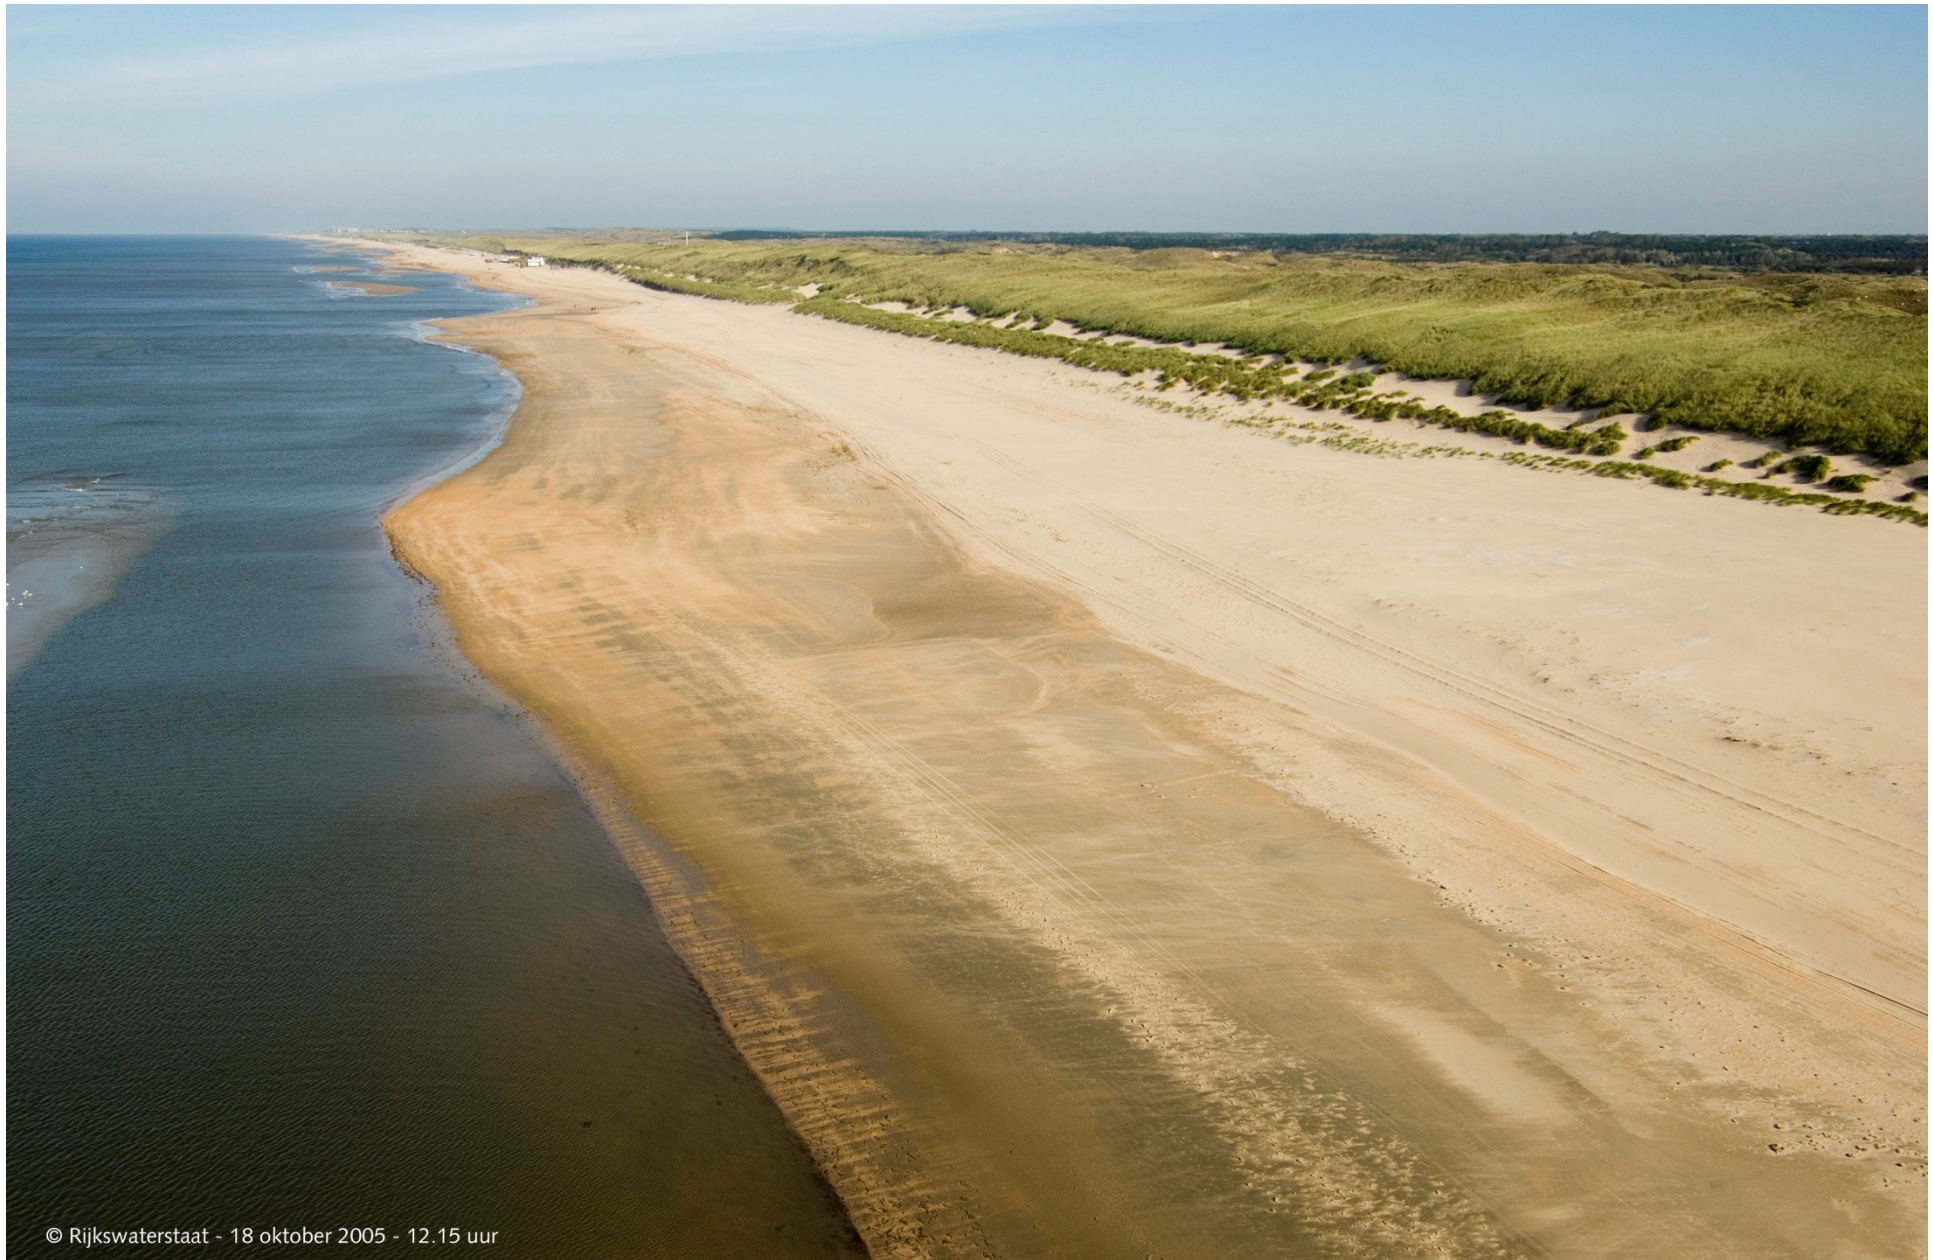
18 October 2005, northern end of nourishment at Heemskerk

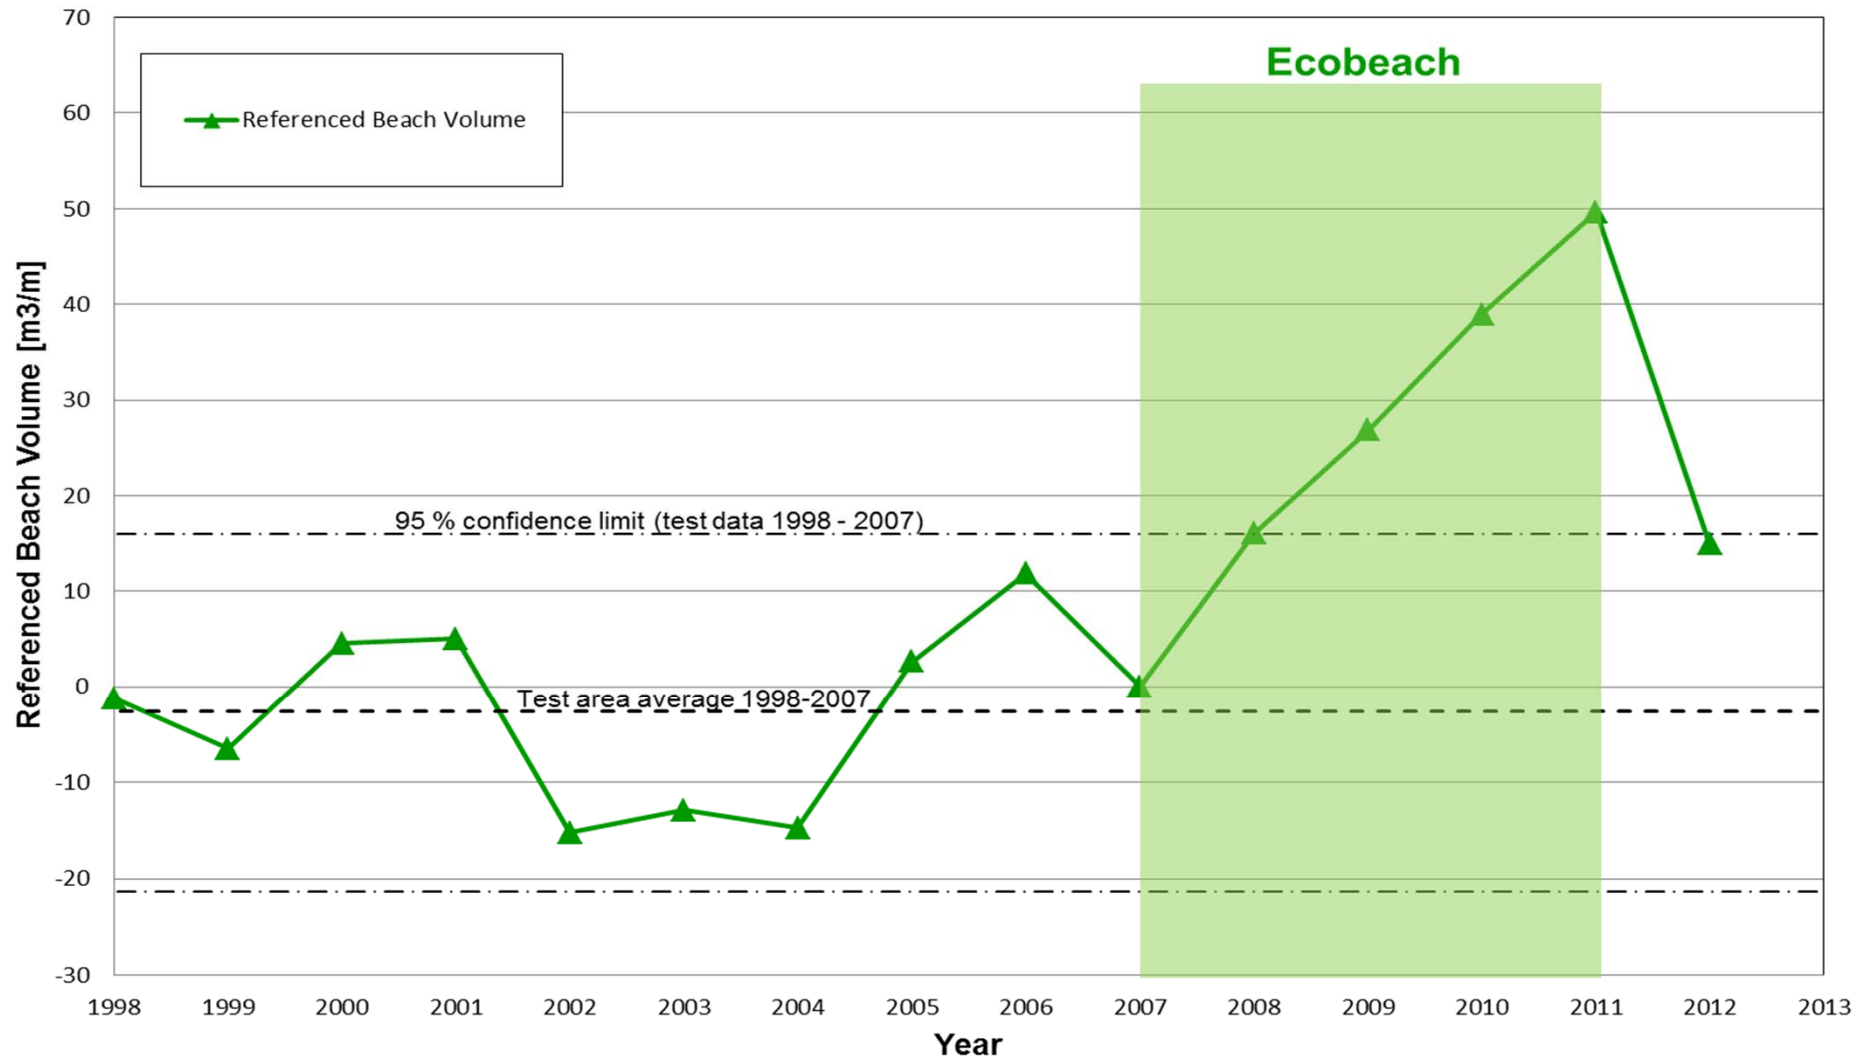
## Referenced Beach Volume test area South, aggregated over 3000 m

The Referenced Beach Volume in test area South has reached the highest value since 1965 during the test period. Growth in beach volume is significant compared to the natural variability (JARKUS data since 1998 is Lidar data, except for 2002)

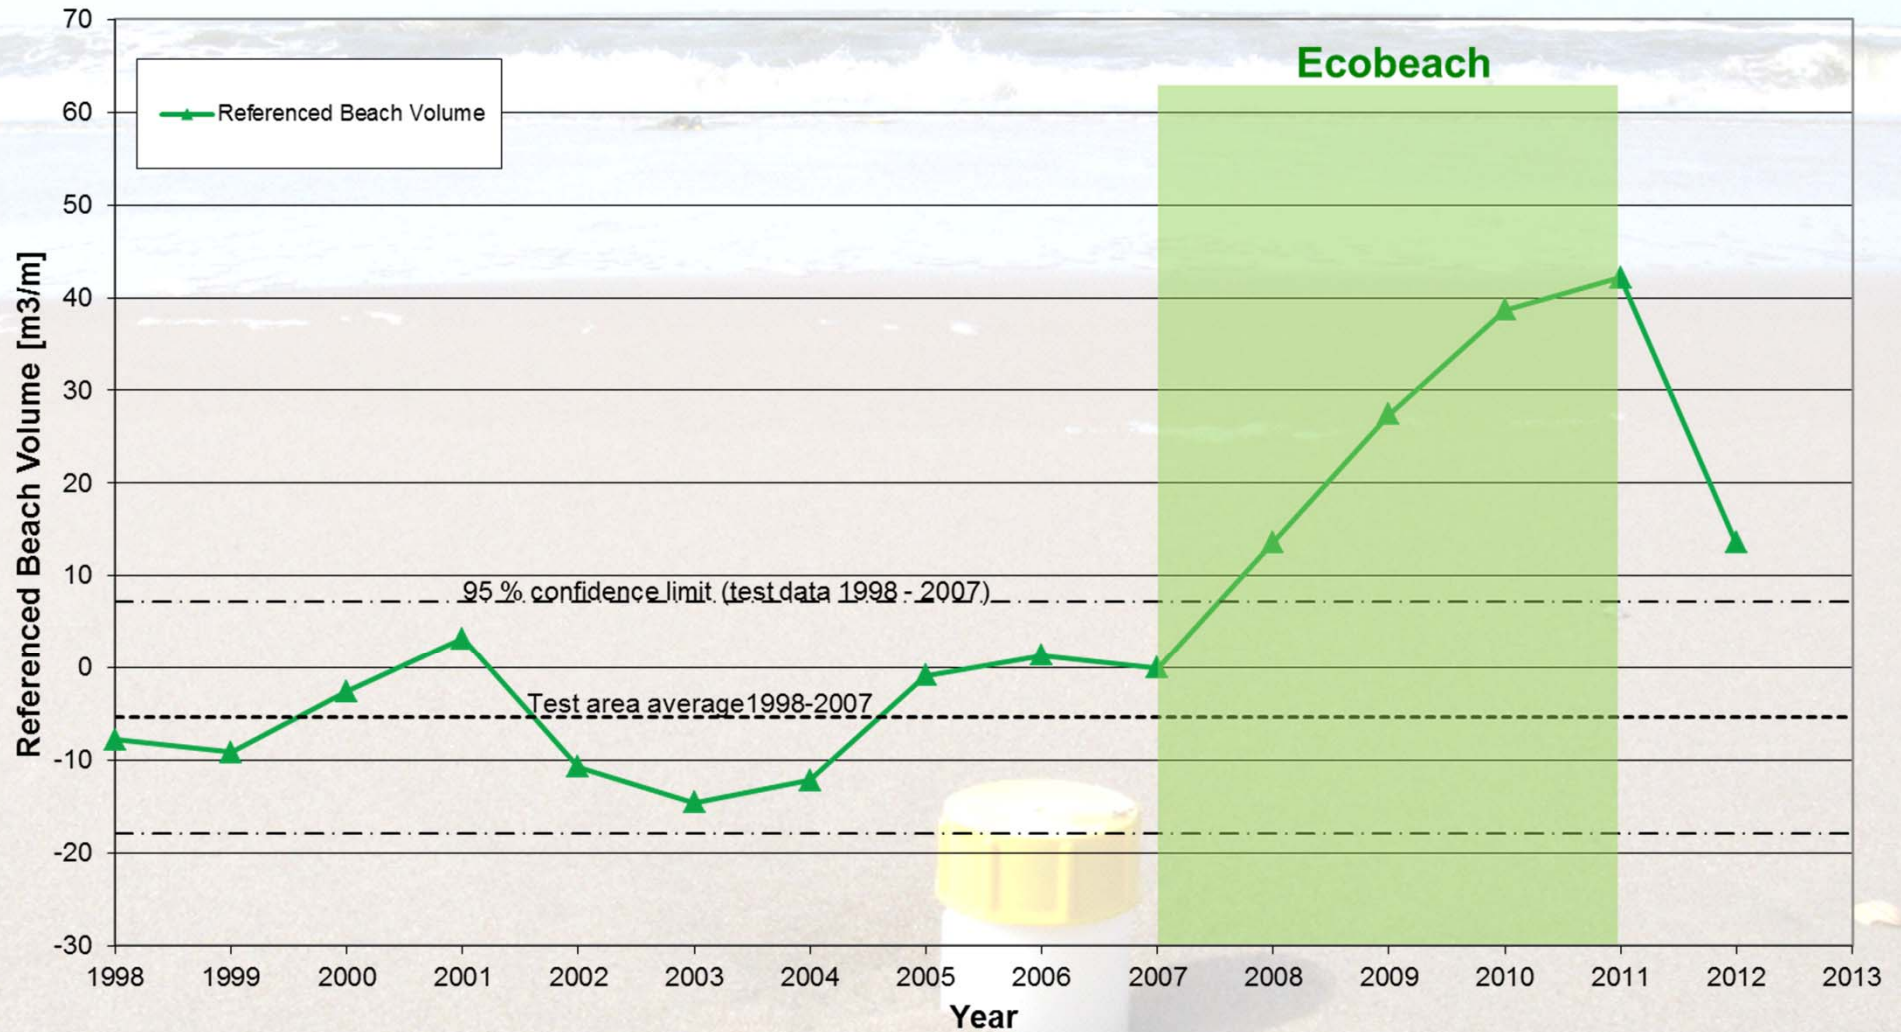
# Referenced Beach Volume test area South, aggregated over 2750 m

Using aggregated values over 2750 m instead of 3000 m gives the same conclusions

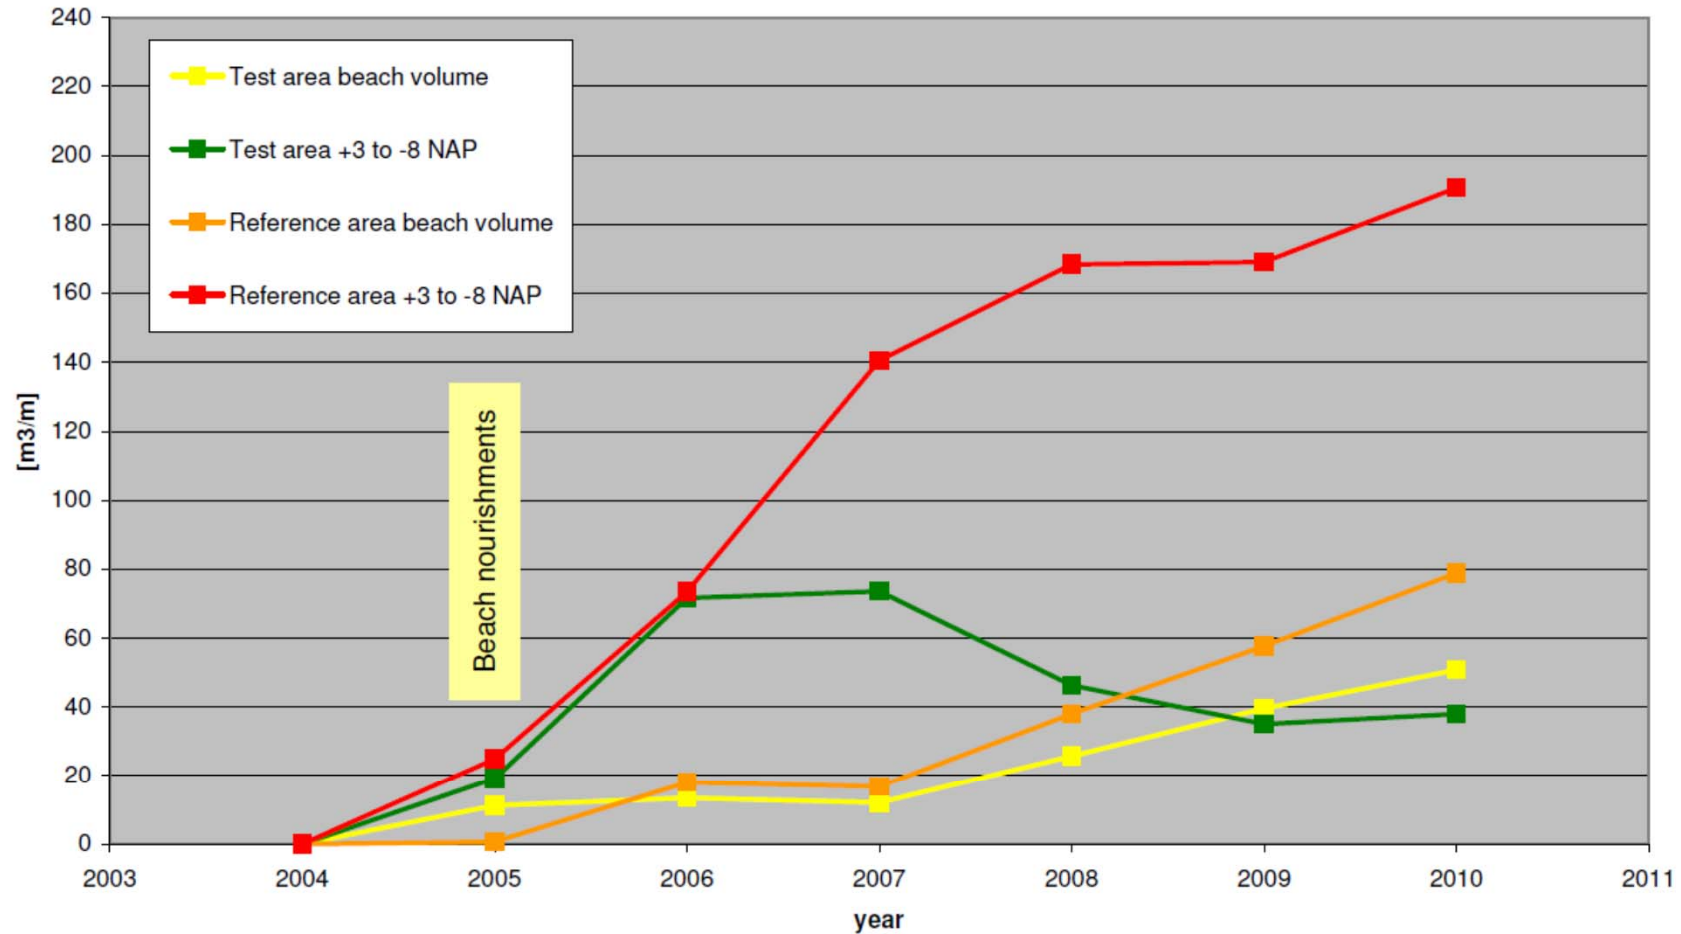
Test and Reference volumes, 2750 m horizontal boxes, referenced, +3 to -8 m NAP

Deltares data, 28 April 2011, Volumes between -8 NAP and dune foot

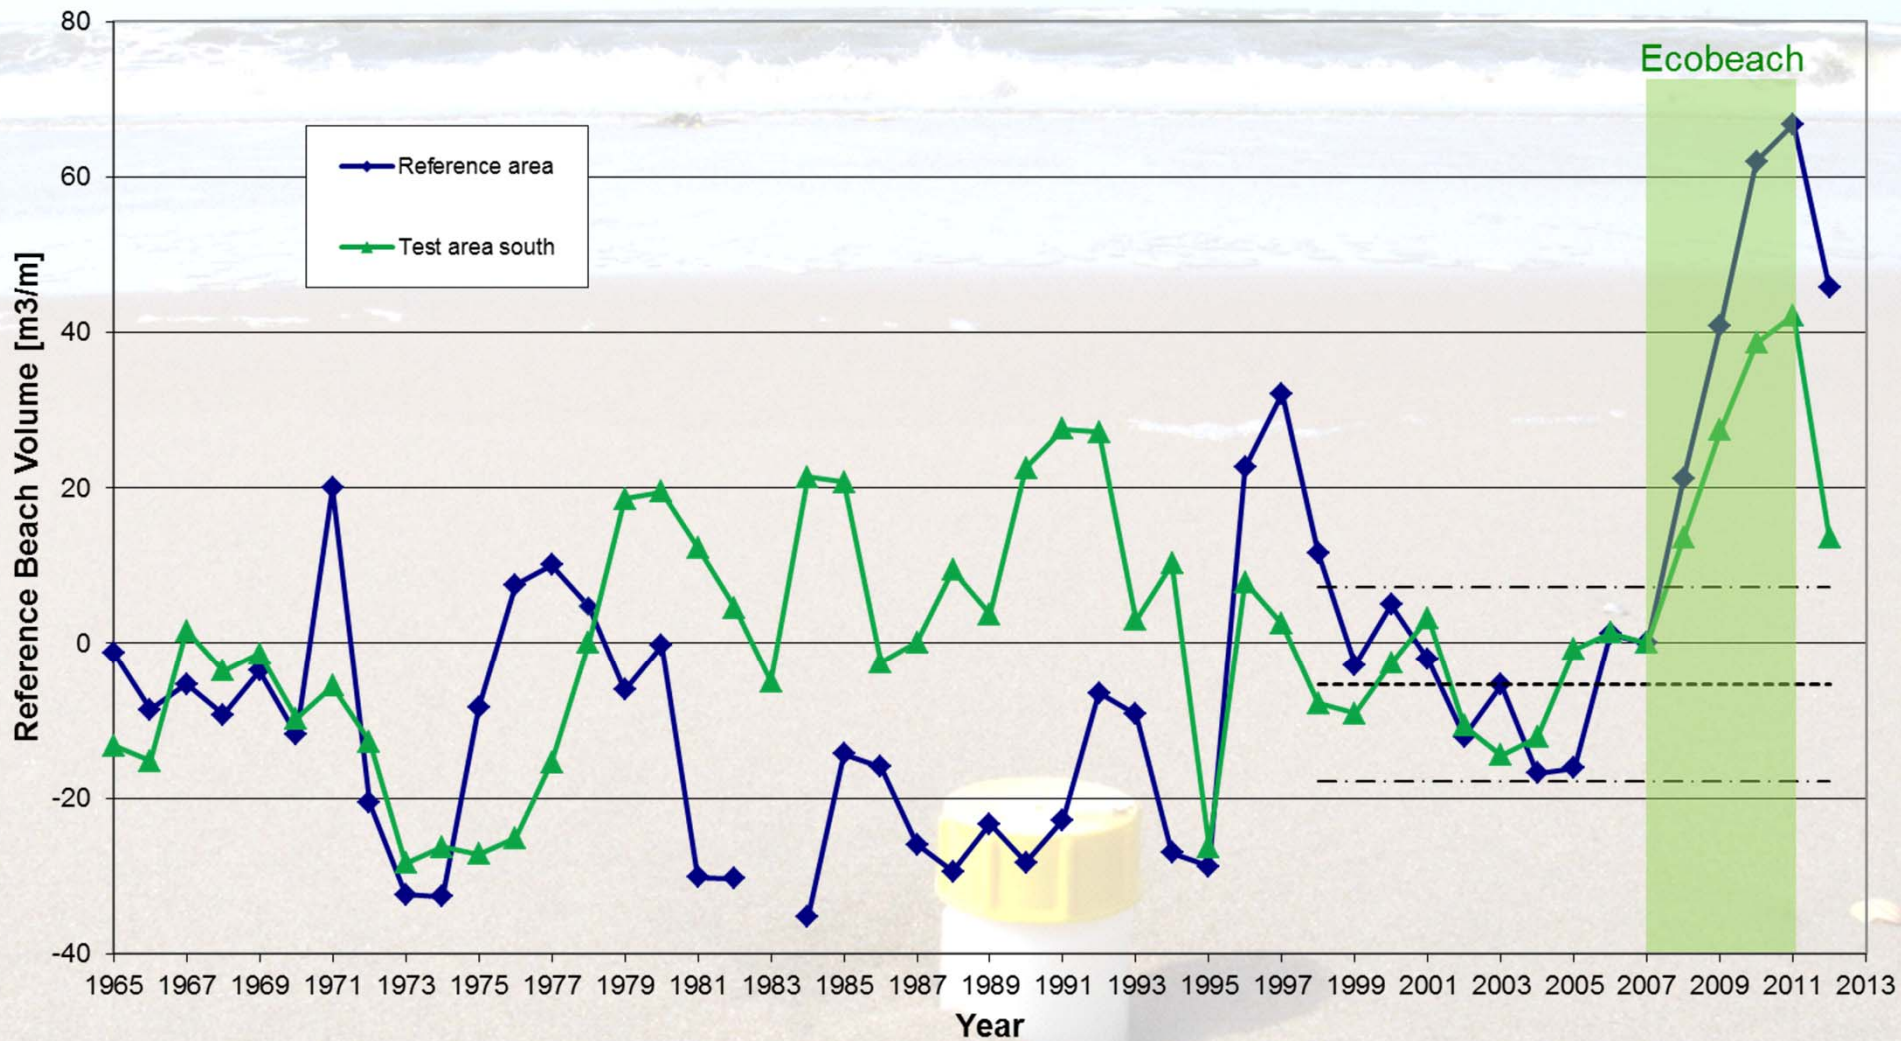
Referenced Beach Volume test area South and reference area, aggregated over 2750 m

No obvious effect of 15-17 year breaker bar cycle

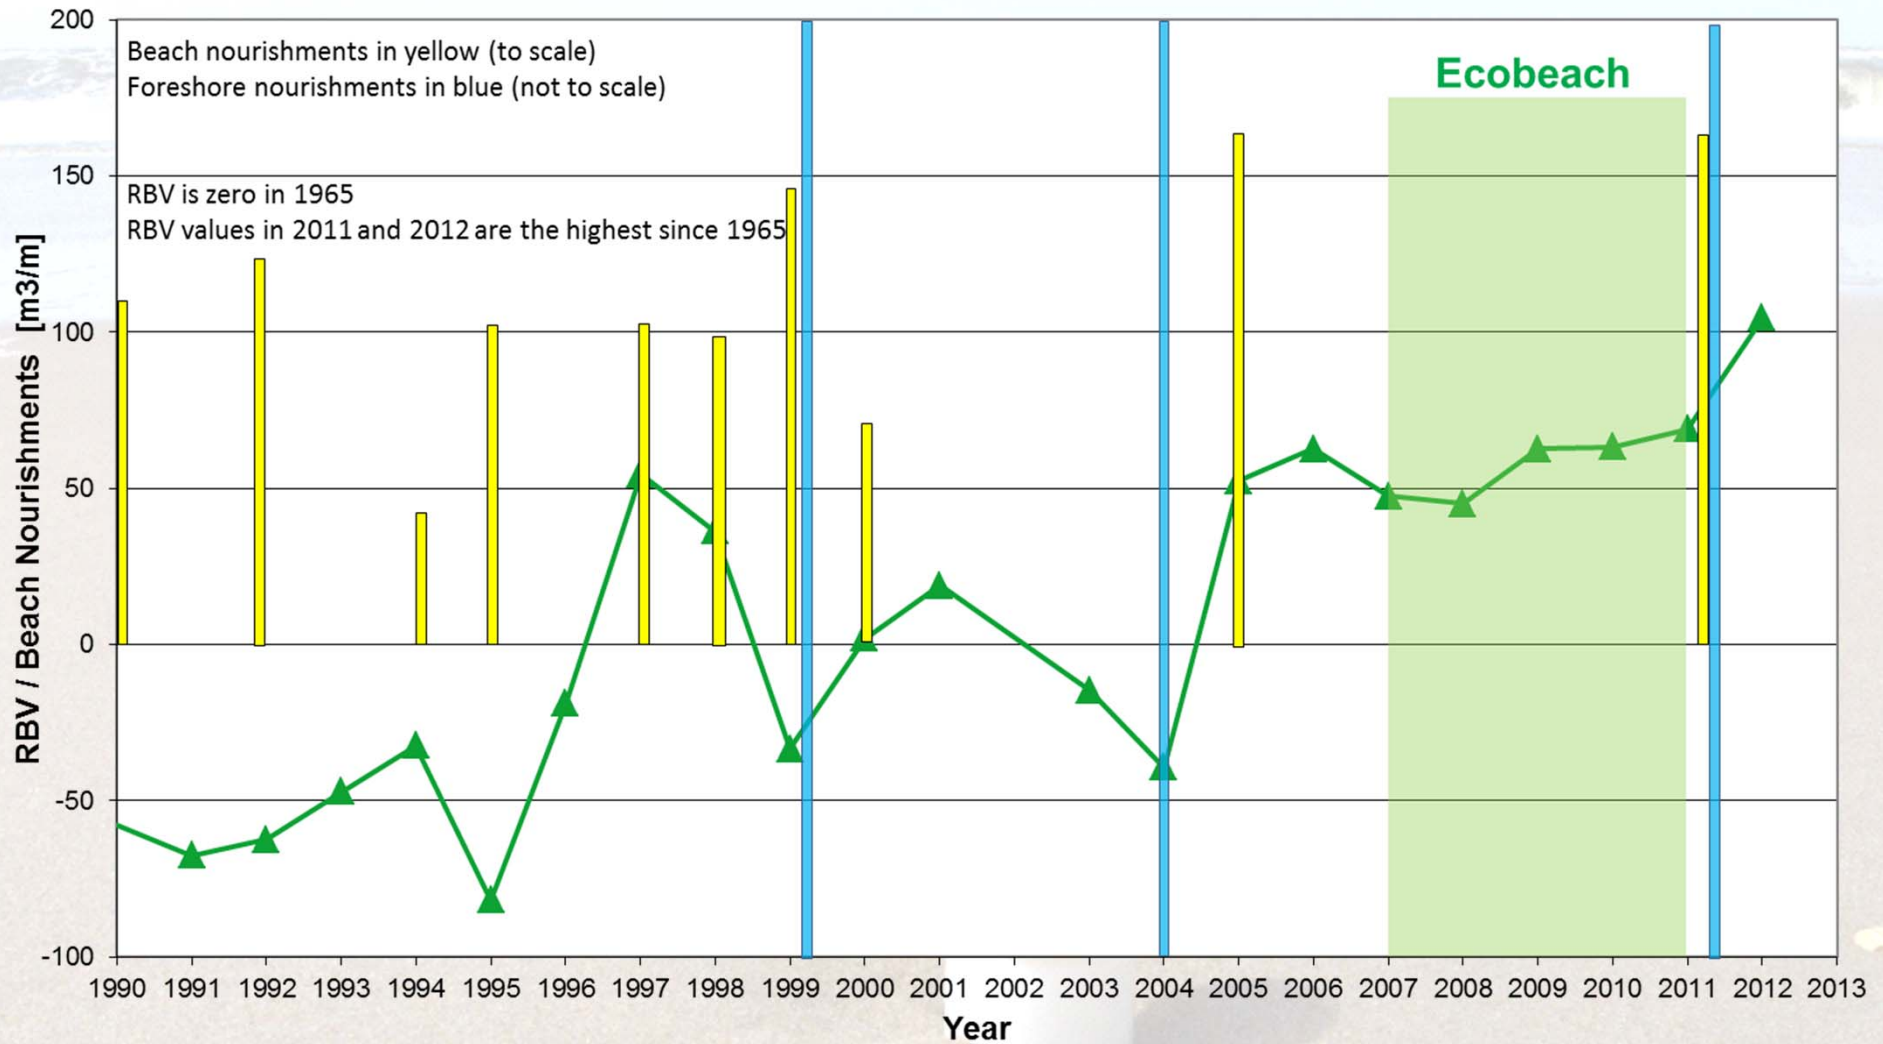
## Referenced Beach Volume, test area North, aggregated over 3000 m

The Referenced Beach Volume in the test area North has reached the highest value since 1965 at the end of the test period, 6 years after the last beach nourishment.

At the end of the Ecobeach test period, both in test area South and North the highest Referenced Beach Volume since 1965 was observed

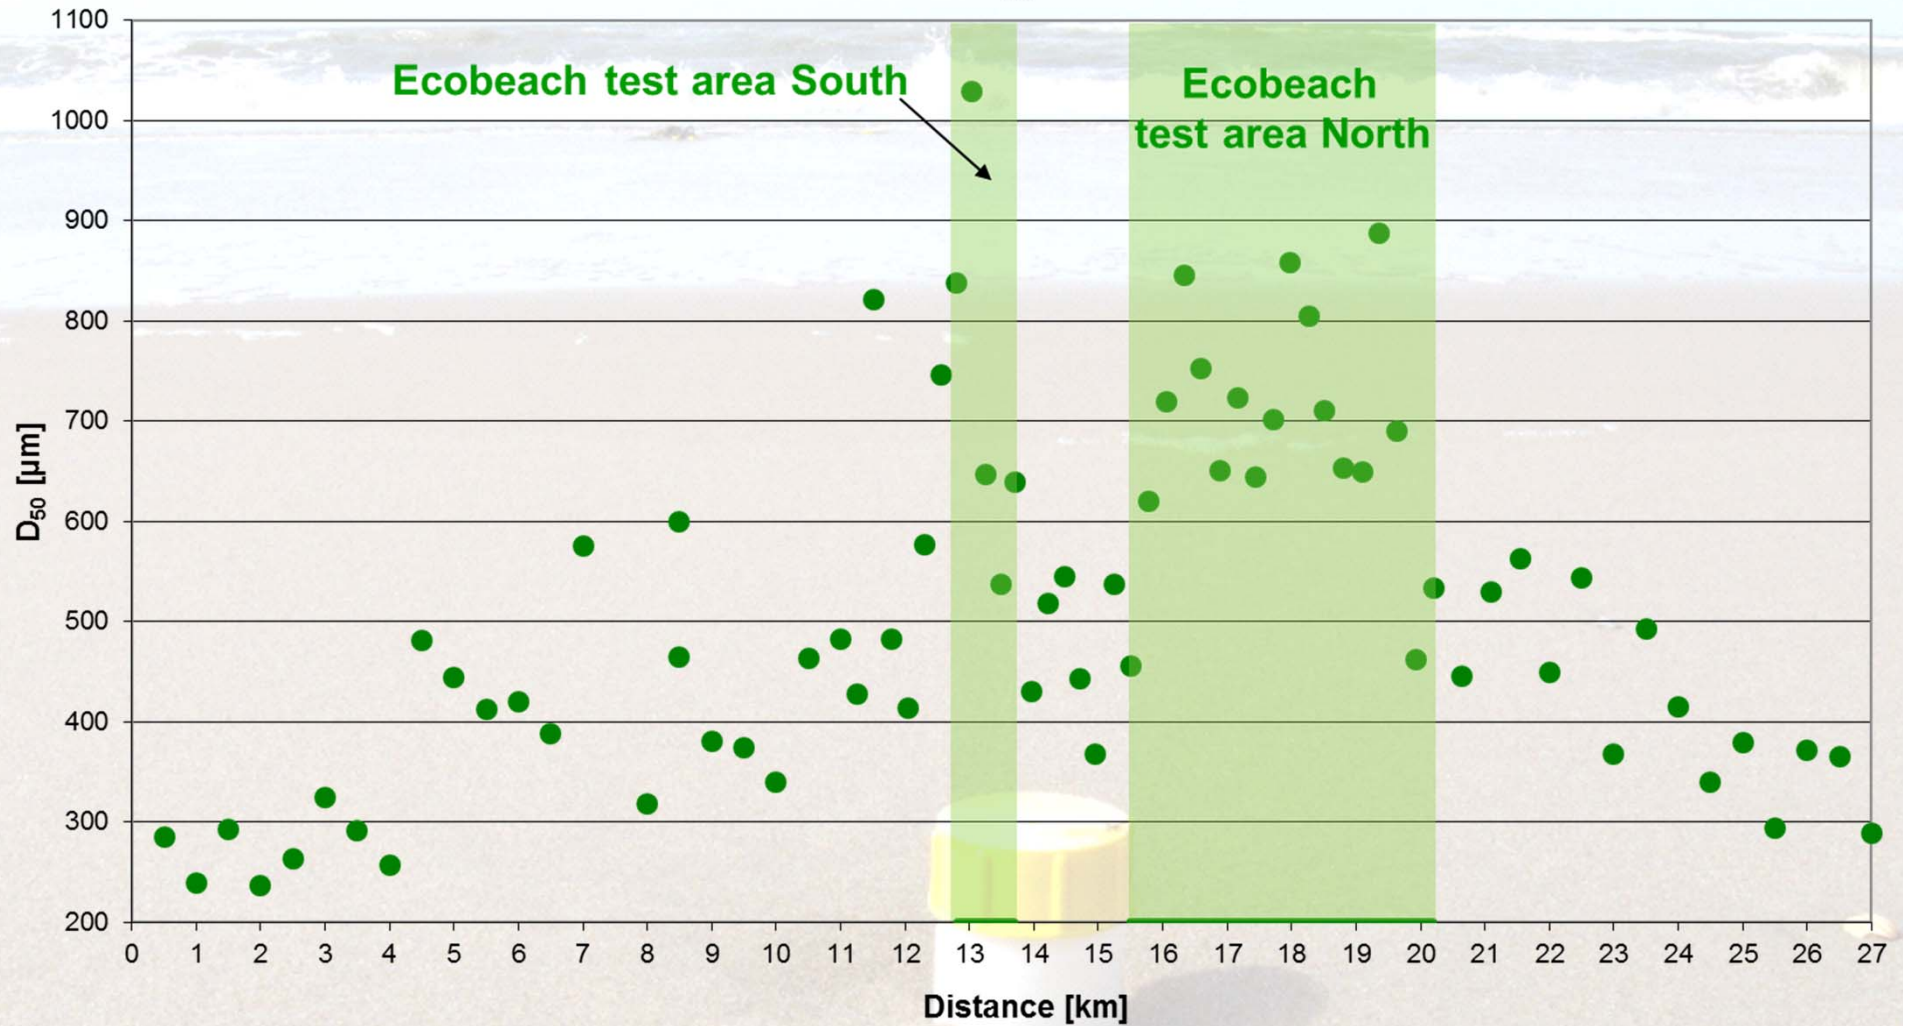
# Mean Grain Size $D_{50}$ Hvide Sande

Significantly coarser sand has been observed in the Ecobeach test areas at Hvide Sande in Denmark

Coarser sand has been observed in the upper 2 m of the beach of test area South and in the test areas at Hvide Sande. The coarser sand may be the result of an increase in wind driven transport of fine sand to the dunes because of a dryer beach. Test area North has been nourished extensively in the past which may explain that no significantly coarser sand has been found in this area
