Ecobeach

A wider and dryer beach by passive drainage

Dutch Ecobeach Pilot (2006 – 2010)

6 km Ecobeach test site - along North Sea coast - Egmond aan Zee (Netherlands)

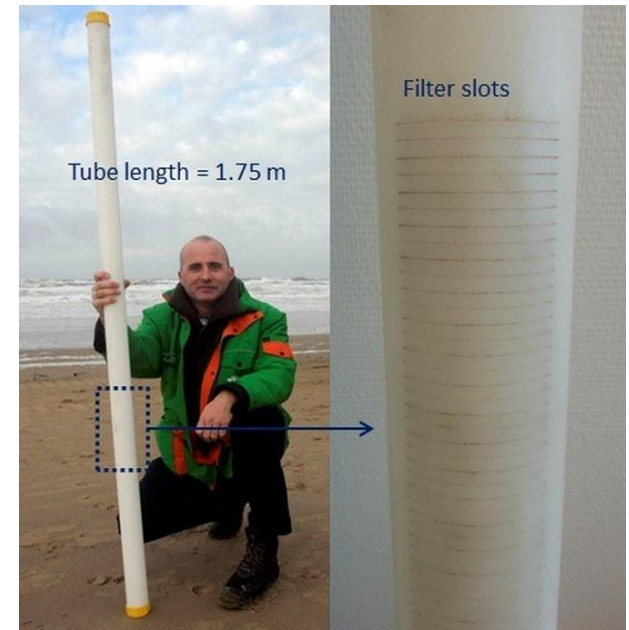
Placement of the Ecobeach drainage tubes

Within the intertidal zone of a sandy beach

Configuration of the Ecobeach tubes:

- Vertical drainage tubes with a length of 1.75 m
- Installed between the high and low waterline at 0.25 m below the beach surface.
- Cross shore interspacing of 10 m
- Long-shore distance between the rows of 100 m.

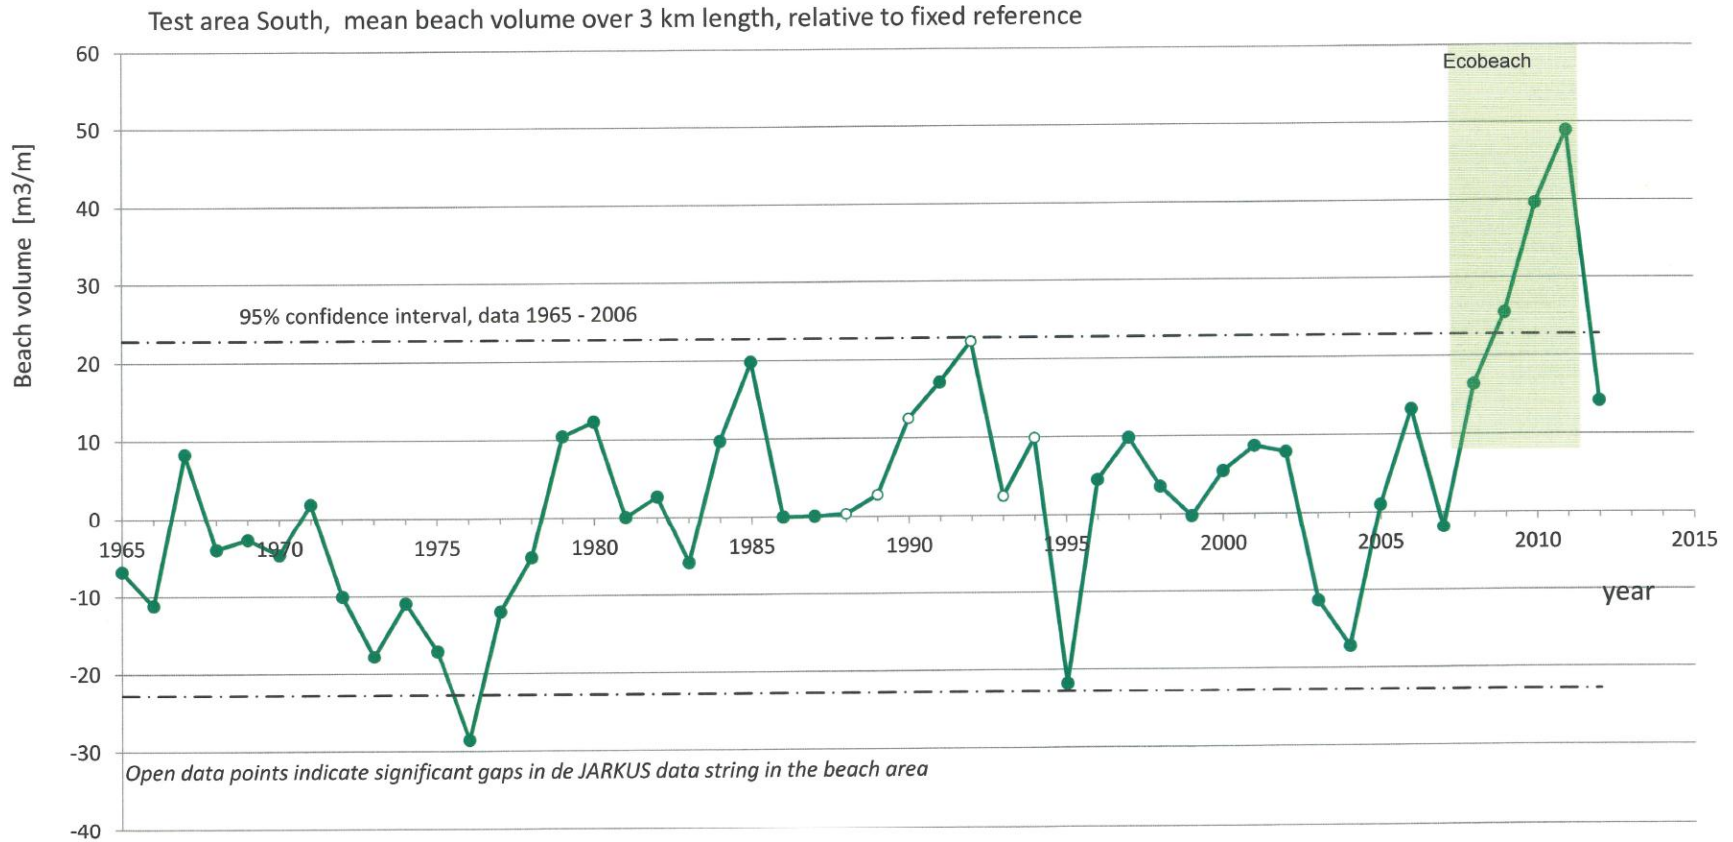
Test results – Beach volume

Highest beach volume ever measured at the test location

Beach volume southern Ecobeach test area (3 km length):

Between 2007 – 2011: 50 m³/m' gain of beach volume

In 2011: highest beach volume ever measured (since 1965)
