Results from the Dutch Ecobeach pilot project

Dutch pilot

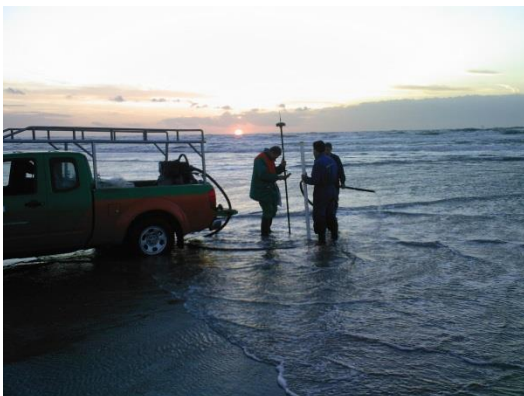
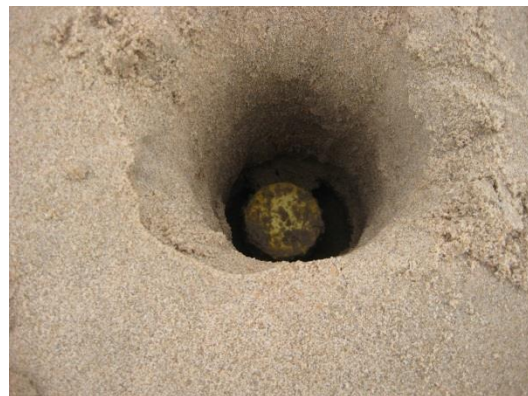
Figure 1: Installation of a drainage tube below the beach surface

A field experiment was carried out for the pilot, in which a statistical analysis was executed for coastal state indicators (CSI's). In addition a scientific approach was used to investigate possible working principles of the system. The drainage system consists of vertical drainage tubes with a length of 1.75 m which are installed between the dune foot and average low waterline at 0.25 m below the beach surface (Figure 1). The tubes have filter slots. The tubes are placed with an interspacing of 10 m in cross-shore rows, while the long-shore distance between the rows is 100 m. Over 600 drains were installed in the test areas.

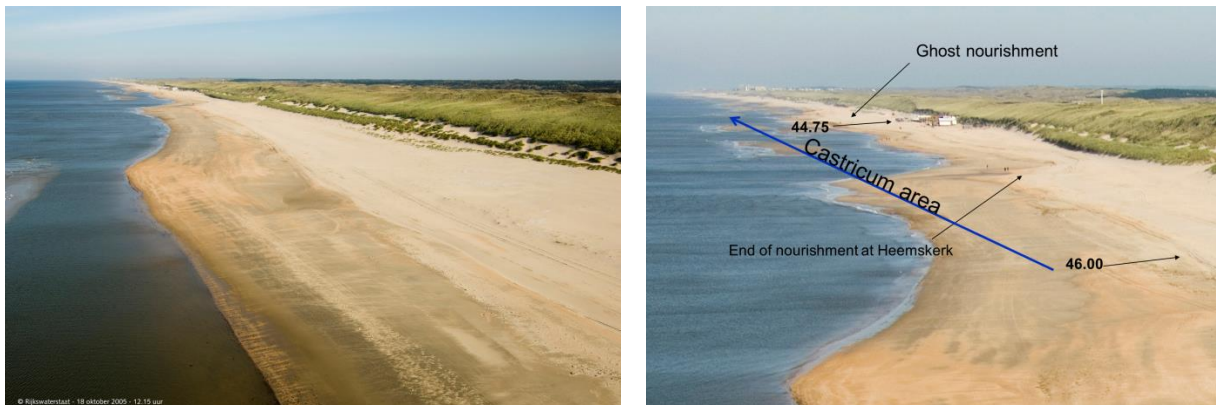
Figure 5: Partly nourished beach of Heemskerk and Castricum (2005)

However, the growth rate of the total volume between NAP -8 m and the dune crest for both areas is different. Due to the foreshore nourishment in 2004 in 200 m of the test area South (up to RSP 40.20), the total volume at this site is significantly increasing until 2006. After 2006, during the Ecobeach period, the northwards directed net sediment transport causes a decrease of the total volume at test area South due to erosion of this foreshore nourishment. While the total volume of test area South decreased during the Ecobeach period, the total volume in the Castricum area increased due to feeding from outside this area. Feeding of the Castricum area has occurred by the 250 m³/m beach nourishment which was placed in the adjacent Heemskerk area in May/June 2005, see Figure 5.

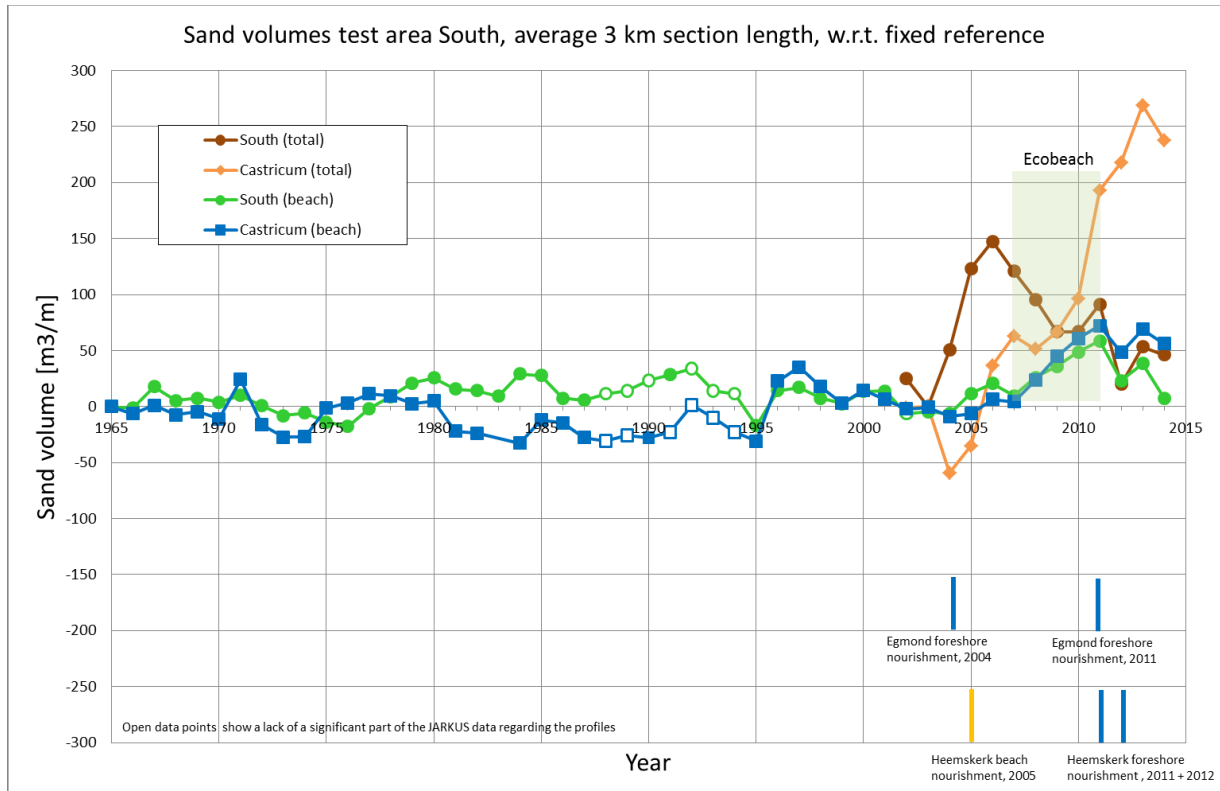
Figure 7: Sand volumes of test area South and Castricum over time, 1965= 0 m³/m

It is rather remarkable that after installation of the Ecobeach system in test area South, both areas show a similar growth in beach volume, while the total volume of test area South decreased and the total volume of the Castricum area increased. Coarsening of sand particles of the upper 2 m of the beach has been observed in the southern test area (Ekkelenkamp, 2011). This coarsening has led to increased beach stability and reduced longshore transport in the southern test area. The Castricum area is wedged in between the 2005 nourishment at Heemskerk and the southern

Ecobeach test area and will have been affected by both the sand feeding from the 2005 nourishment at Heemskerk and the beach growth and coarsening in the southern test area. It is remarkable that although from 2005 onwards the total volume from NAP -8 m to dune crest of the Castricum area started to grow significantly, only after installation of the Ecobeach system the beach volume started to show a significant growth (Figure 7). It has been observed that after installation of the Ecobeach system an increase of Aeolian transport occurs (Pieterse, 2009). This Aeolian transport is not bounded by artificial human demarcations. Also during severe wave conditions and during storm surges, when dune erosion takes place, sand will move from one area to the other.

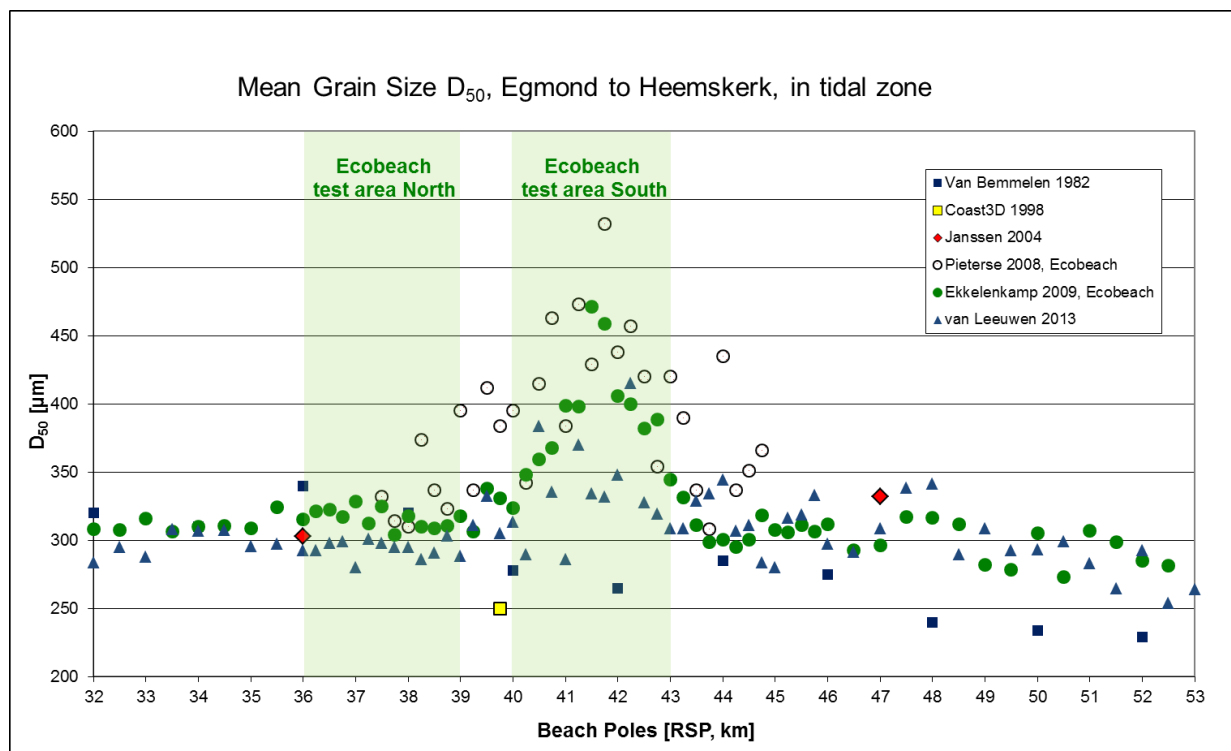
Figure 11: Grain size D_{50} during and after the Dutch Ecobeach pilot

Many sand samples were analyzed by using a laser diffraction spectrophotometer. Most important property output for the purpose of this investigation is the grading and the grain shape of the sample. Beach sampling was carried out along 20 km coastline including the Ecobeach test areas. The granulometric analysis comprised the comparison of the sediment data from before, during and after the test. To determine the sediment properties, cone penetration tests and boreholes were made. The results showed a significant coarsening of the sediment in the active zone of the beach at the test area South. The upper 2 m of the beach is defined as the active beach zone. Moreover, soil stratification was observed. The beach consists of horizontal layers with each layer containing its own permeability. The drainage tubes connects the highly permeable layers resulting into drying of the beaches after high water conditions. Dry beaches promote Aeolian transport of fine sediments to the dunes. Therefore, sediments at the beach become coarser leading to a higher permeability. The last measurements in 2014, three years after the end of the test period, resulted in a decrease of the presence of relatively coarse material within the southern test area. Test area North did not show significant coarsening of the sediments during the Ecobeach test period. This may be due to the extensive nourishments of this area with offshore sand and thus absence of coarser fractions. Investigations in Denmark also showed the presence of coarser sand in two Ecobeach test areas along the coast of Hvide Sande which is also located on the North Sea coast.
