Ecobeach

A sustainable beach by drainage

Brouwersdam, 3-10-2014

Head of Coastal Department BAM Infraconsult

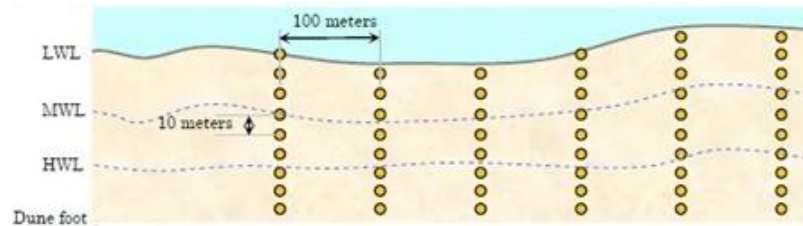
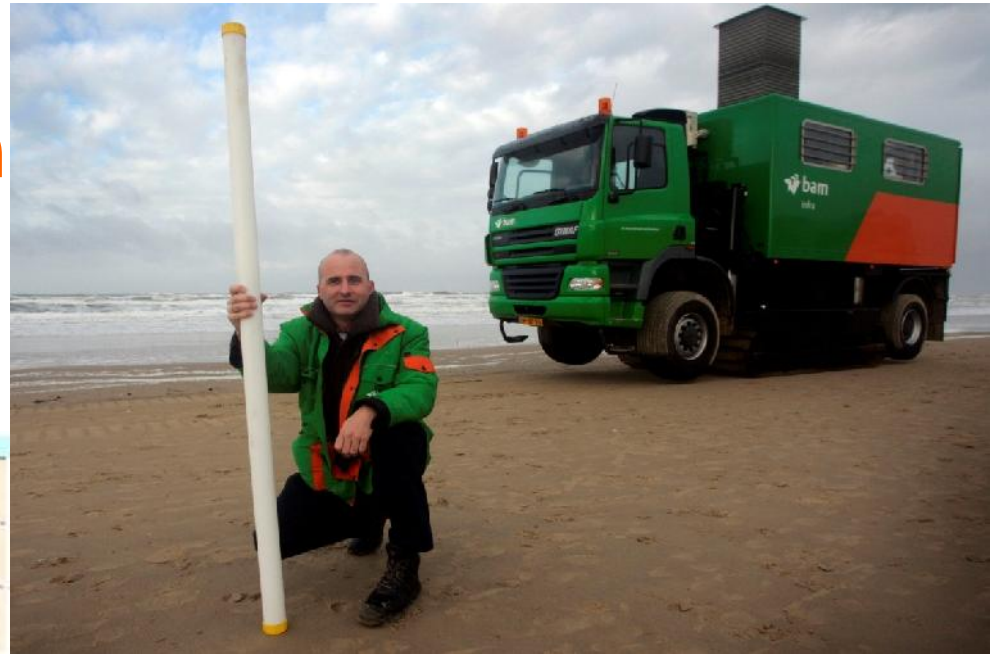
What is Ecobeach

- Ecobeach is a vertical beach drainage
- Passive drainage, so no CO₂ emission
- Vertical drainage tubes are placed in a row pattern
- These rows are placed perpendicular to the coast
- A row of drainage tubes are located every 100 meter along the coast
- Average 10 tubes each row, installed every 10 m between low and high waterline (dune foot)
- The tubes are installed below the beach surface (not visible)

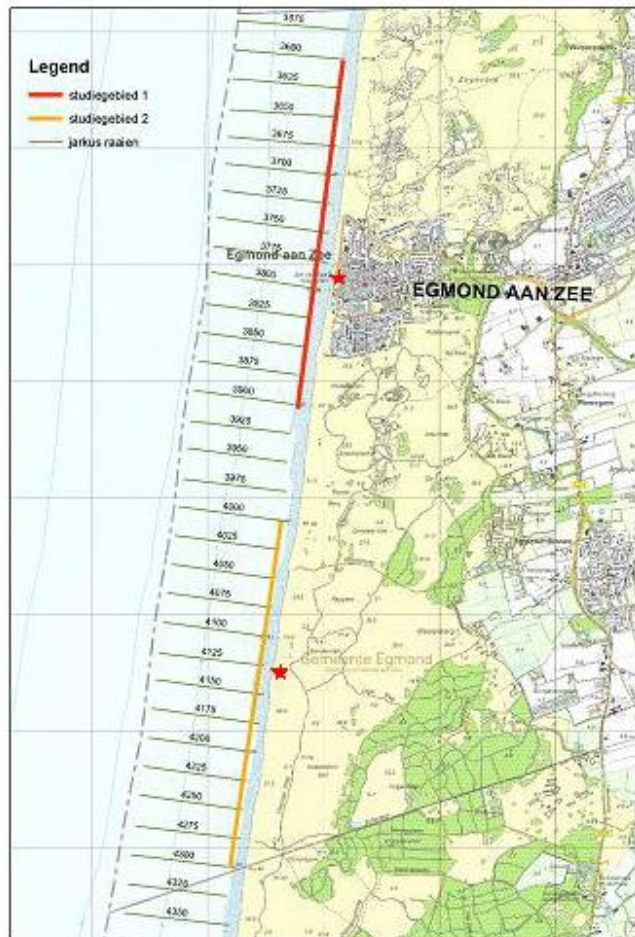
Ecobeach test in Egmond

- BAM proposed to the Dutch Department of Public Works to carry out a test in Egmond
- Two test areas with a length of 3 km each
- Northern test area nourished every 5 year
- Southern test area is relatively undisturbed
- Argus cameras are available at both test areas
- Annual JARKUS measurements since 1965
- Test was performed in agreement with all the stakeholders:

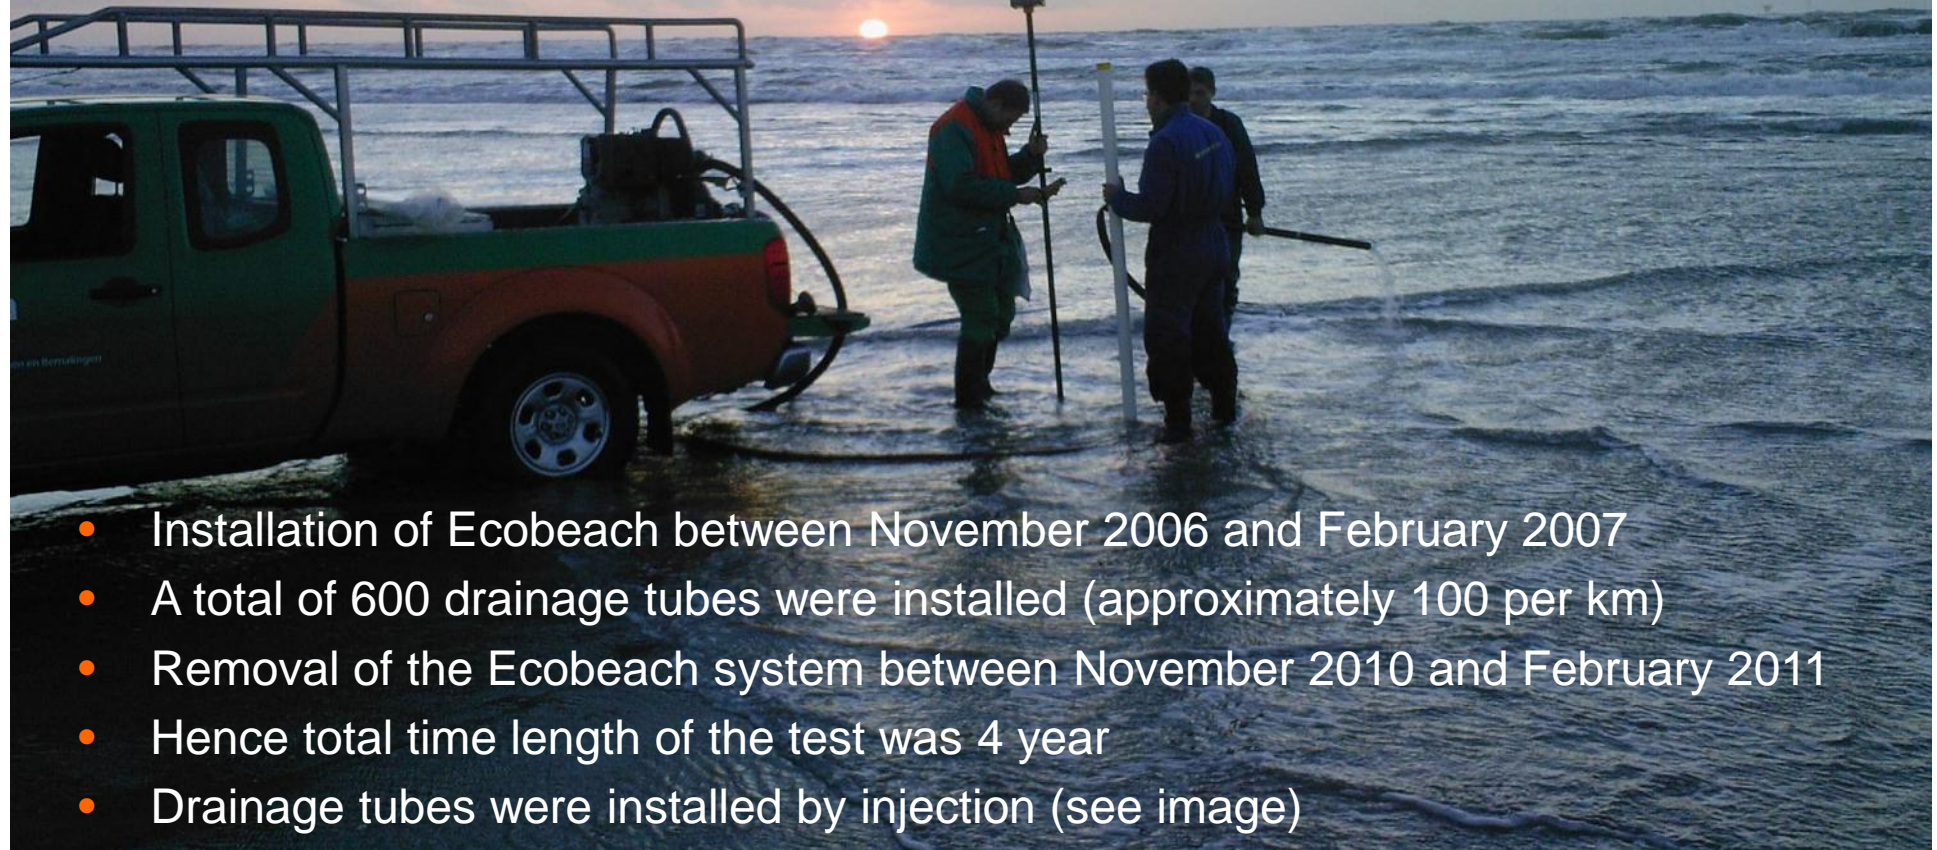
Ecobeach test in Egmond

- Installation of Ecobeach between November 2006 and February 2007
- A total of 600 drainage tubes were installed (approximately 100 per km)
- Removal of the Ecobeach system between November 2010 and February 2011
- Hence total time length of the test was 4 year
- Drainage tubes were installed by injection (see image)

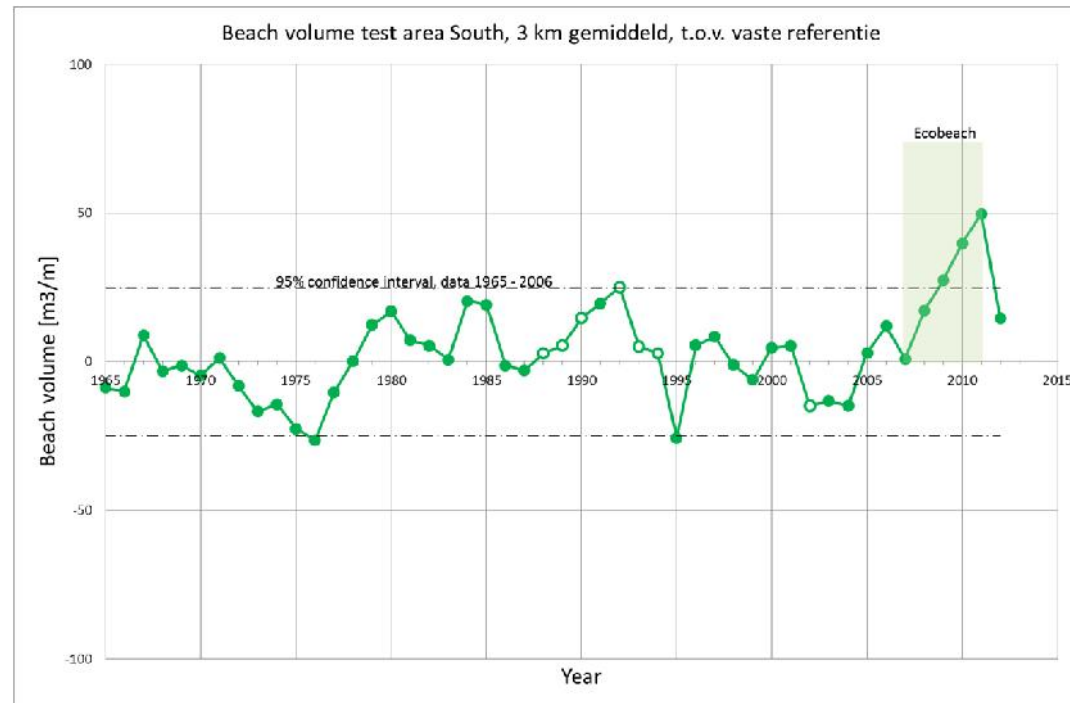
Ecobeach at an undisturbed beach area

- Beach volumes variation w.r.t. long-term average
- From 1965 to 2007 a natural variation of the beach volume around the average
- Variation includes effects of storms, embankment and nourishments outside the area
- Beach accretion of 50 m³/m during Ecobeach; 150.000 m³ in 3 km section
- Highest beach volume ever measured in 2011, since 1965
- Nearly back to long-term average in 2014, despite of adjacent nourishments

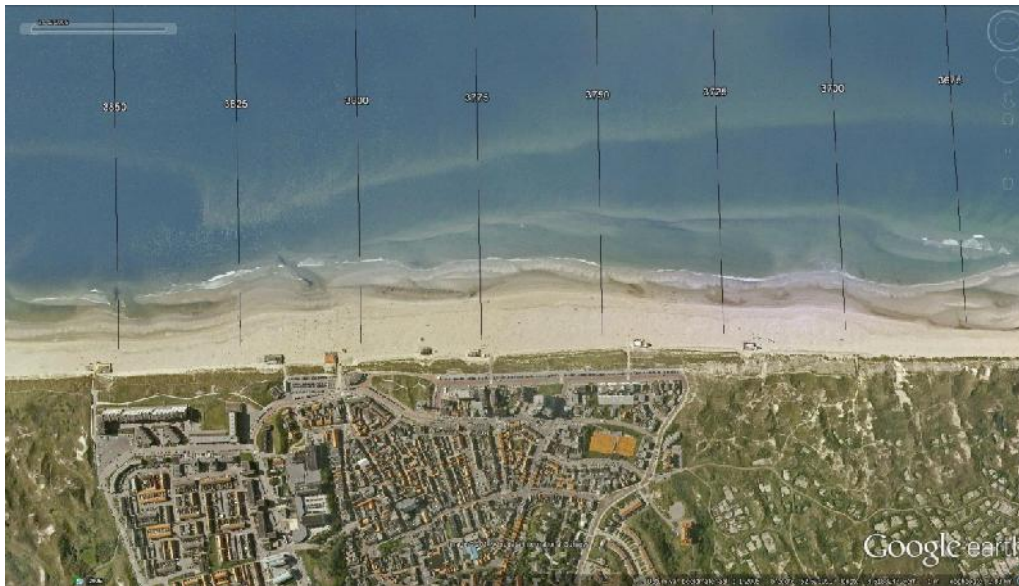
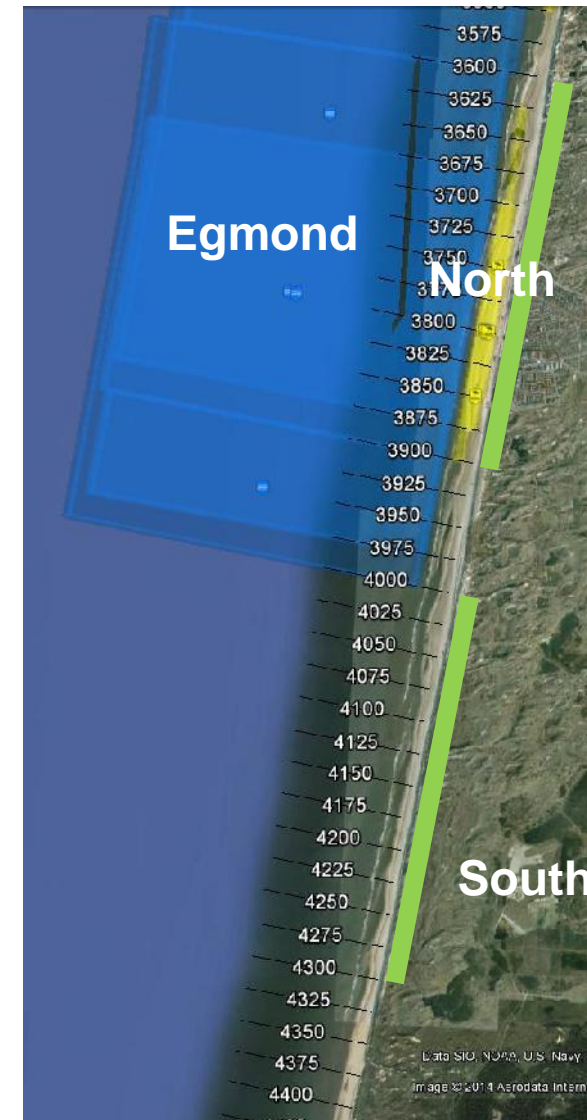
- Beach nourishment in Egmond started in 1990
- Both beach and foreshore nourishment
- Replenishment of 486.000 m³ at the beach of Egmond (216 m³/m) in April/May 2005
- Installation of Ecobeach started in Egmond in November 2006
- Ecobeach installed at the nourished area

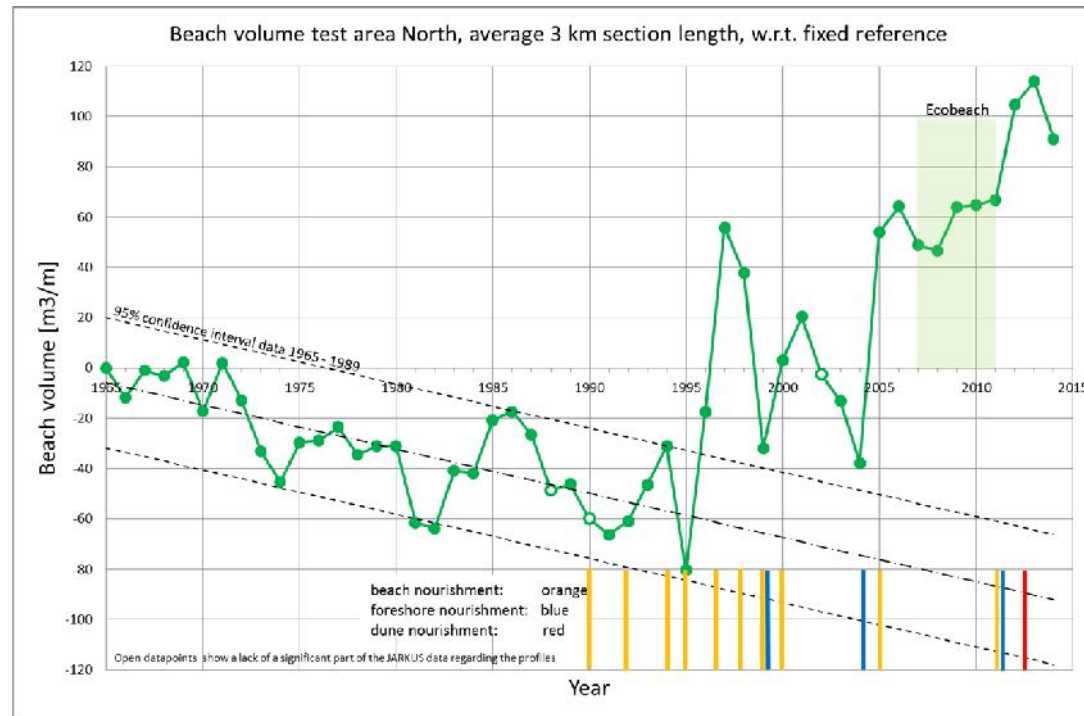
Ecobeach at a nourished beach

- Until 1995 decrease of beach volumes
- After 1995 recovery after nourishments
- Lifetime of beach nourishment approximately 5 years
- Beach volume increases during Ecobeach test, does not decrease
- In January 2011, 6 years after nourishment, highest beach volume since 1965
- Beach nourishment of March 2011 largely eroded in 2014

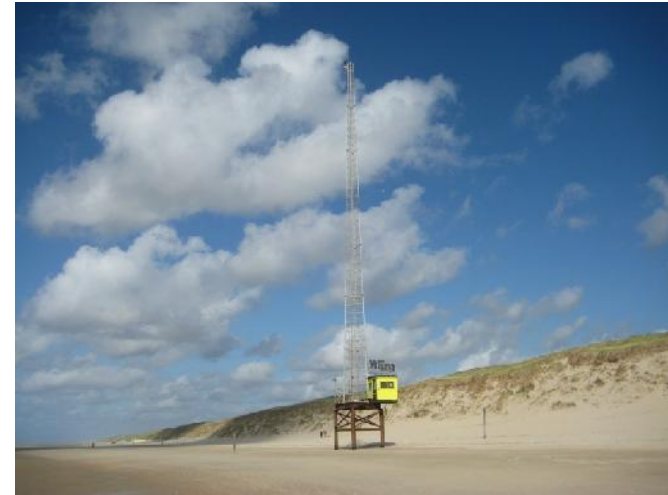
Argus images

- Every half an hour, a photo of the beach is captured
- The next Argus photos show the situation during low water:
 - 21 September 2006 Just before Ecobeach
 - 21 September 2010 During Ecobeach
 - 21 September 2014 2.5 year after Ecobeach
 - 21 September 2015 3.5 year after Ecobeach

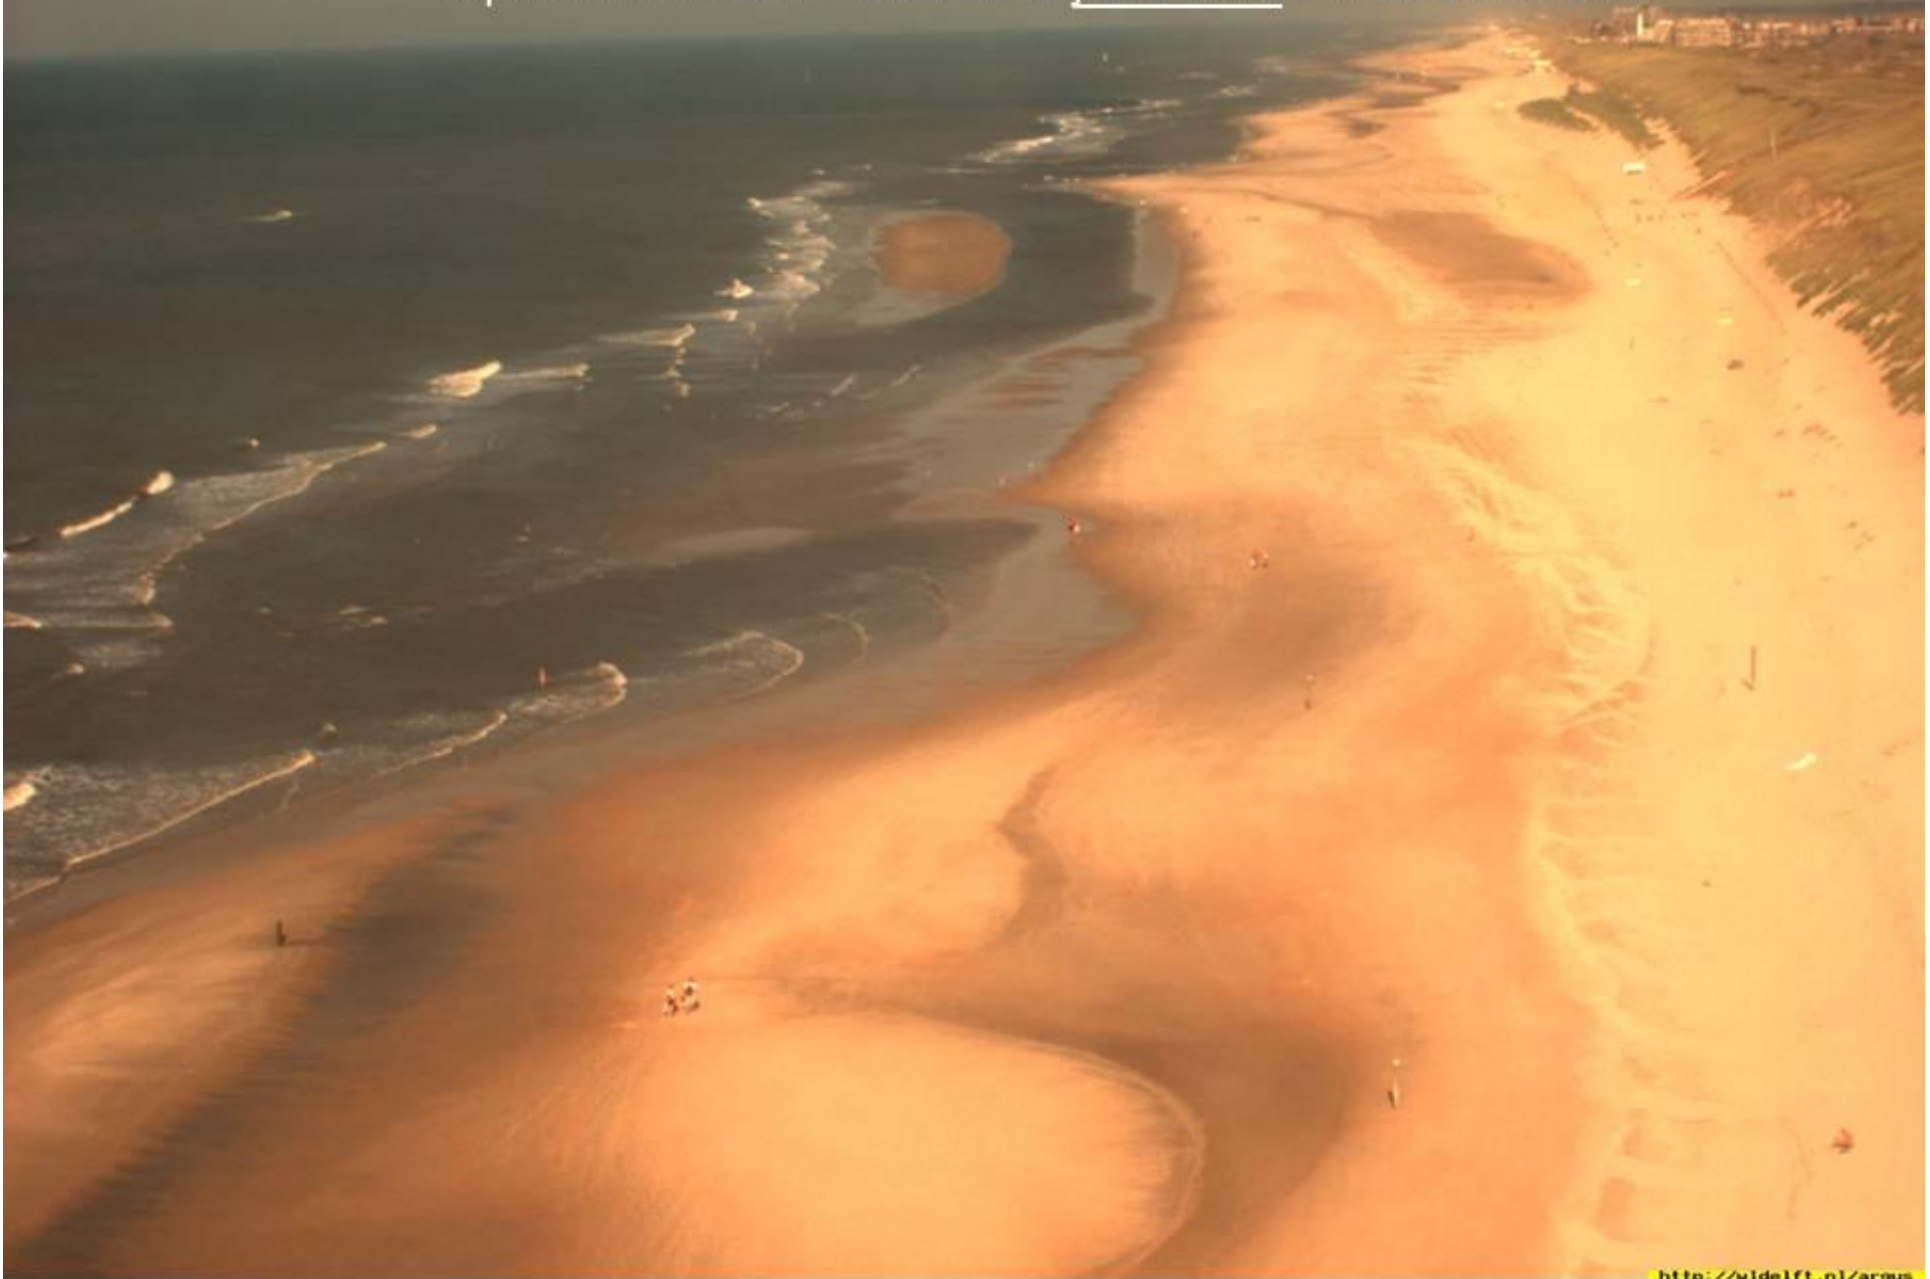
September 21 2006 13:30:03 → just before the Ecobeach test

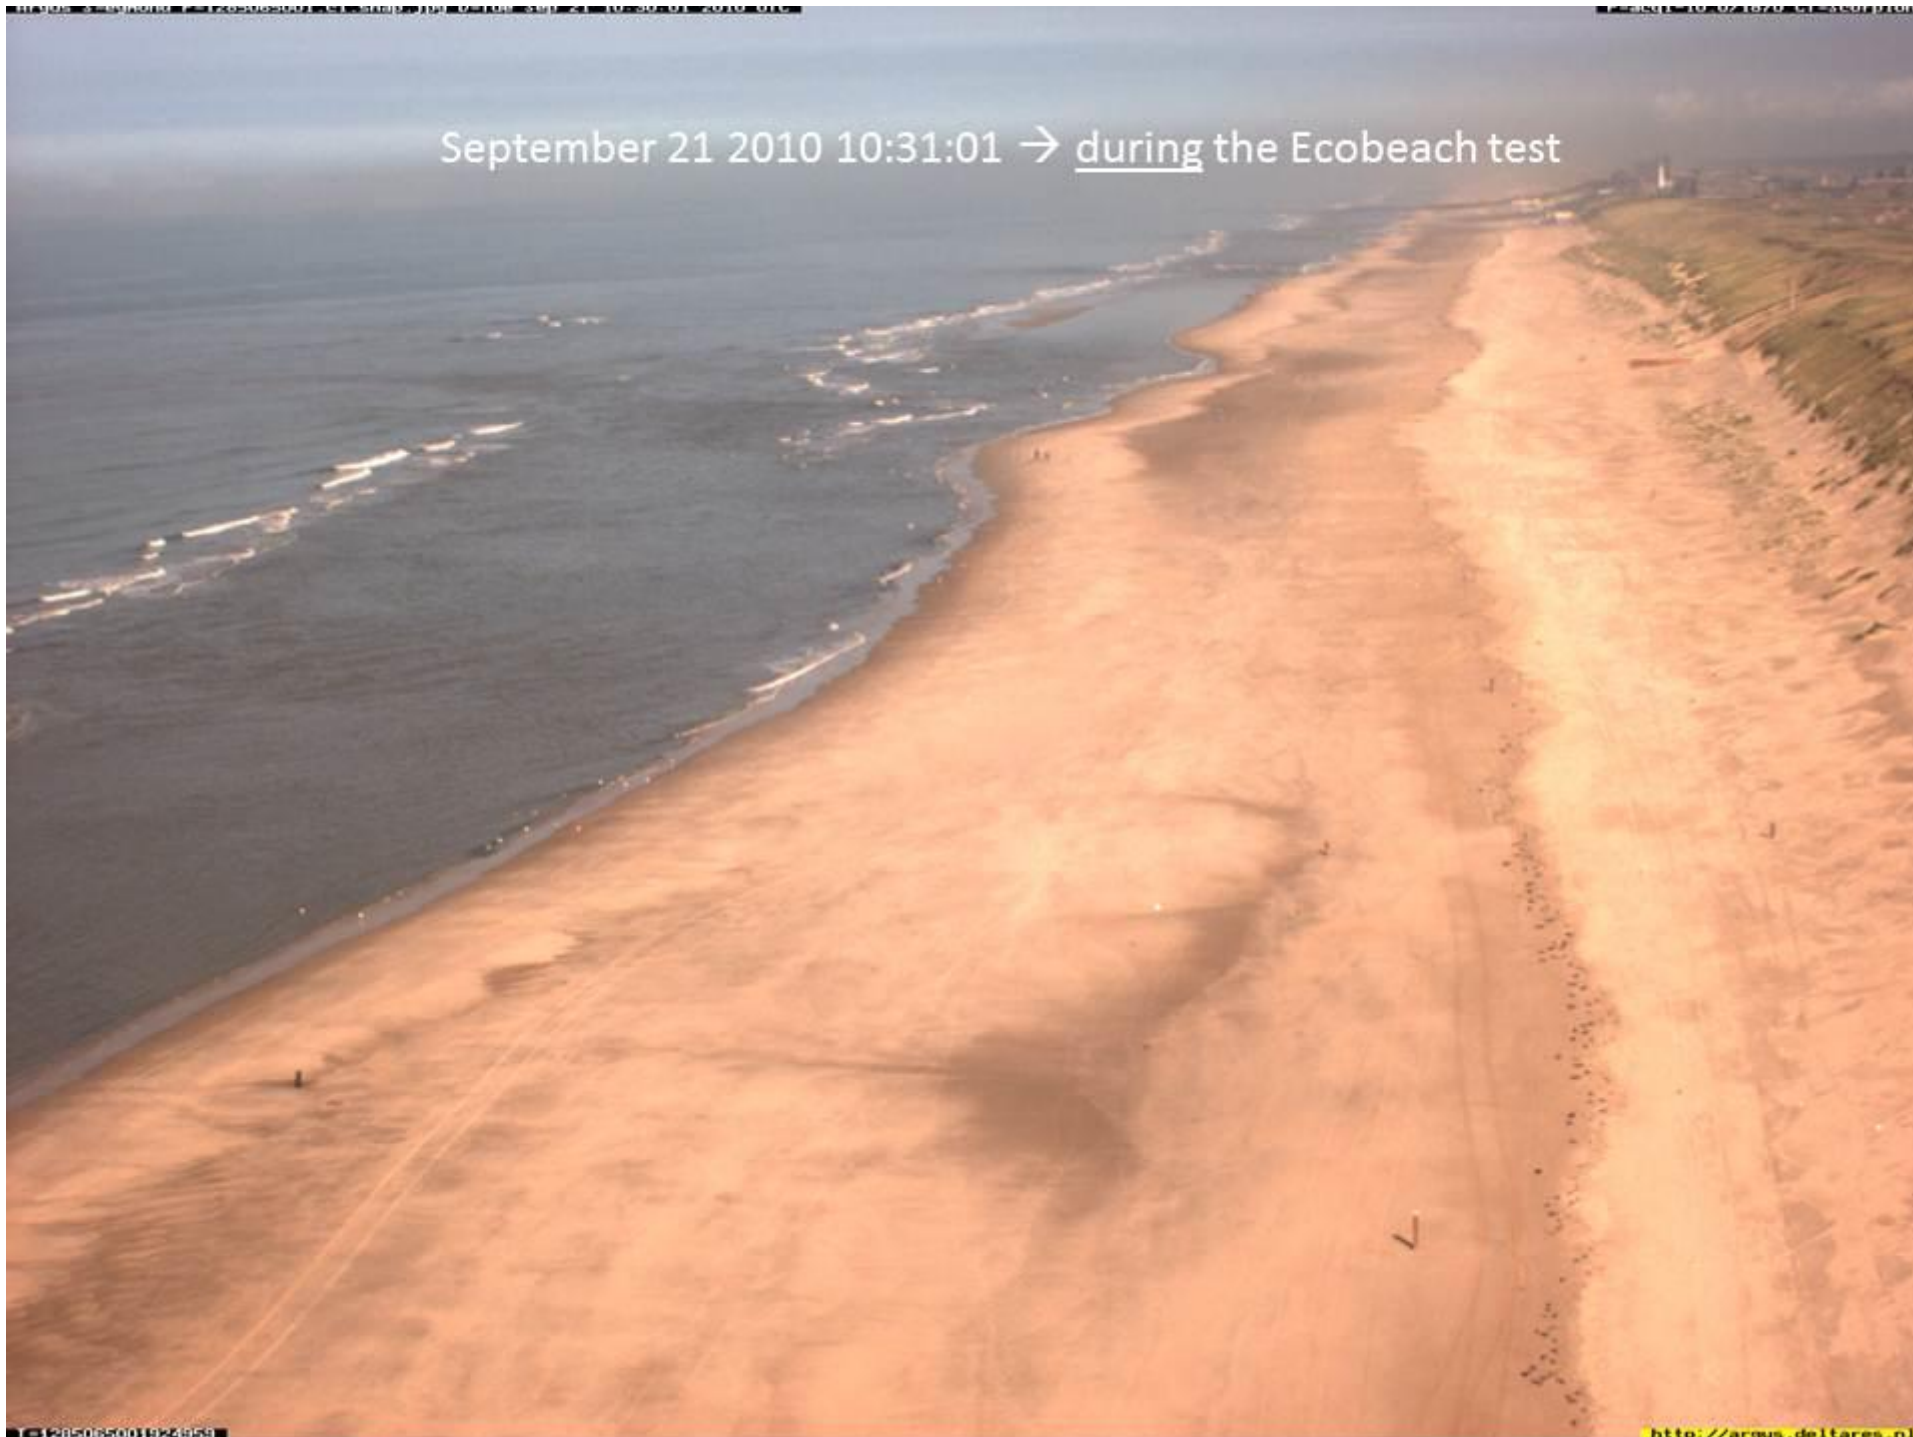
September 21 2010 10:31:01 → during the Ecobeach test

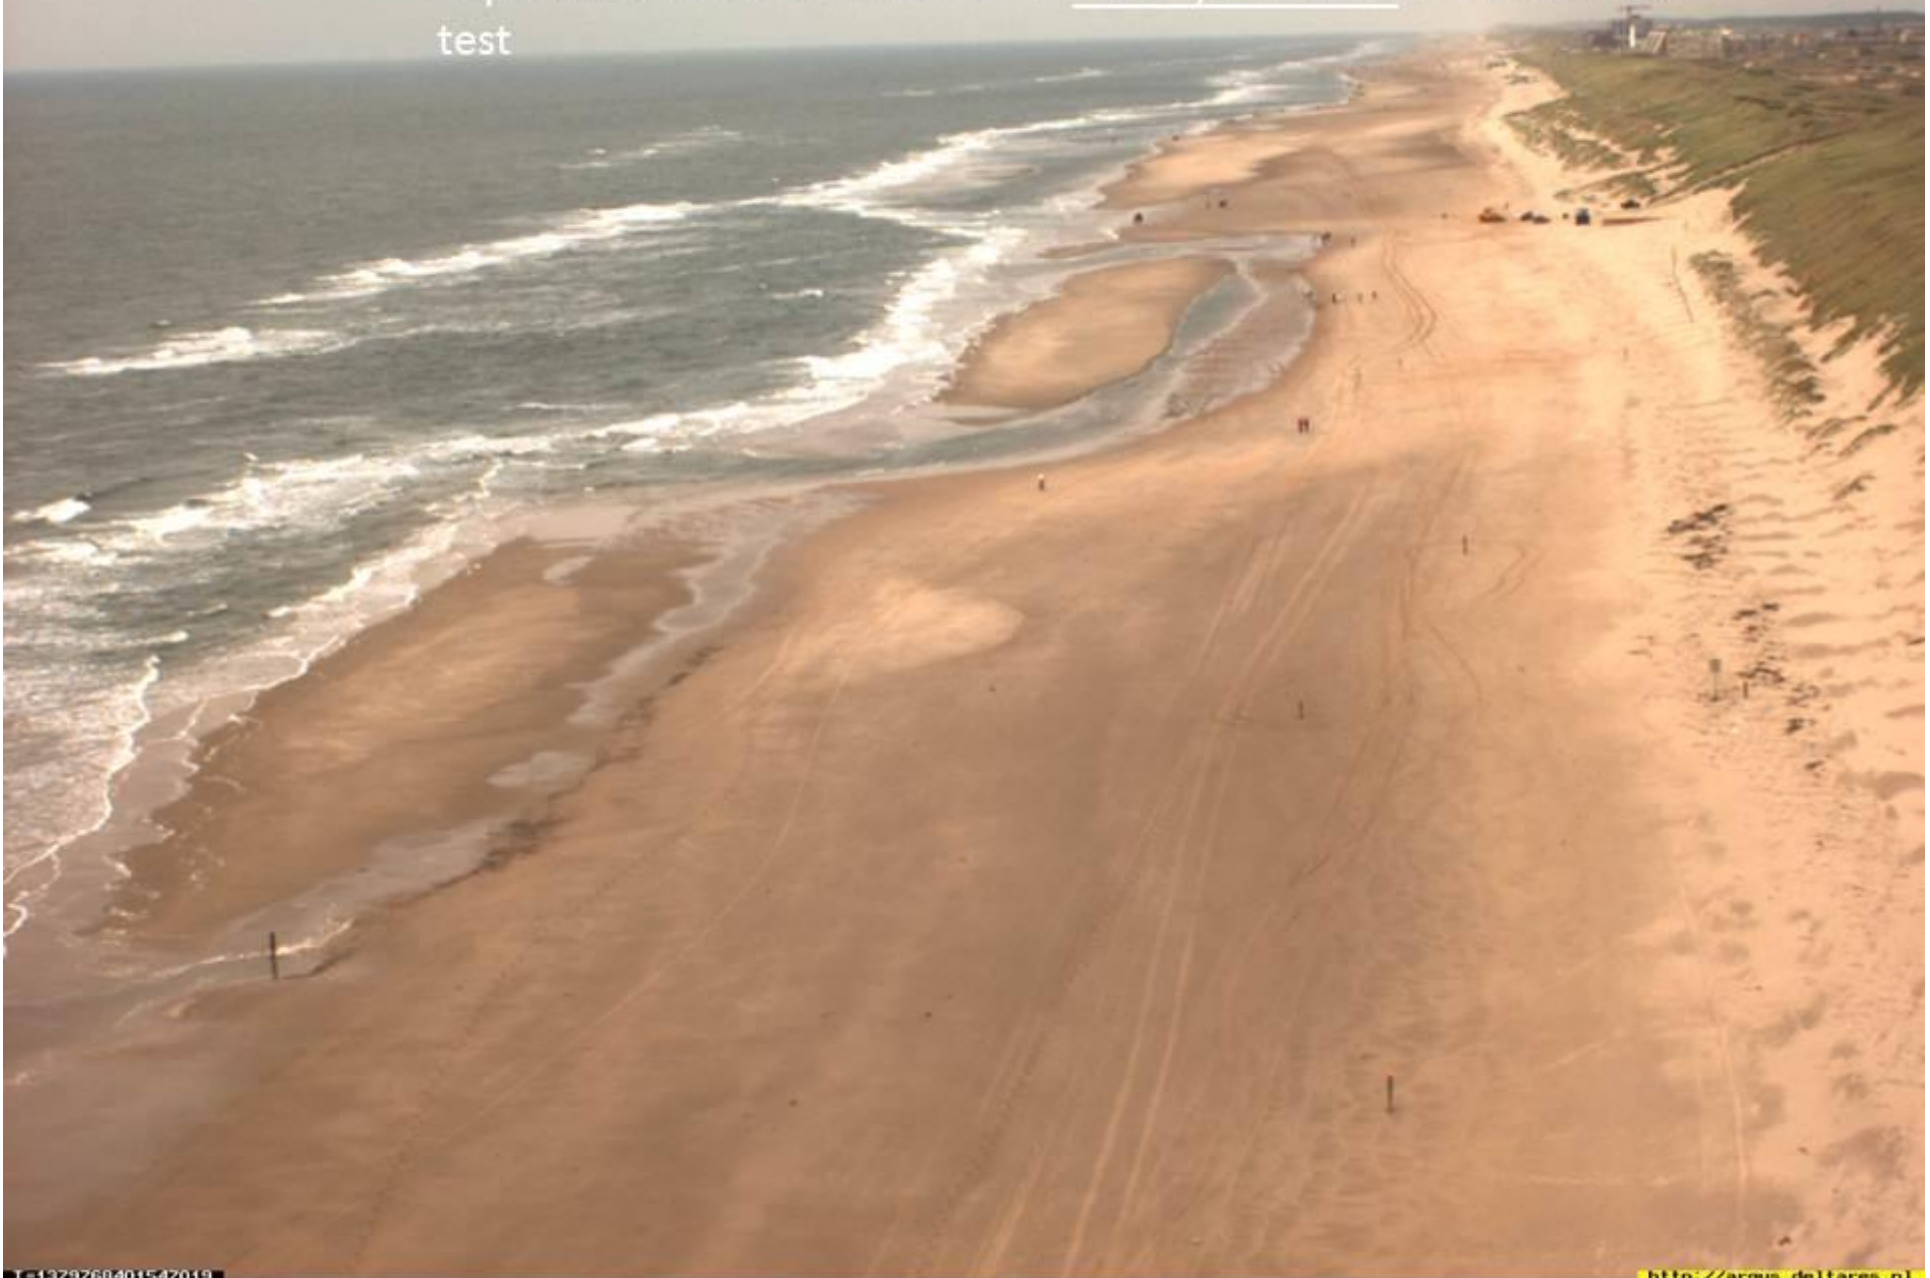
September 21 2013 13:00:01 → a few years after the Ecobeach test

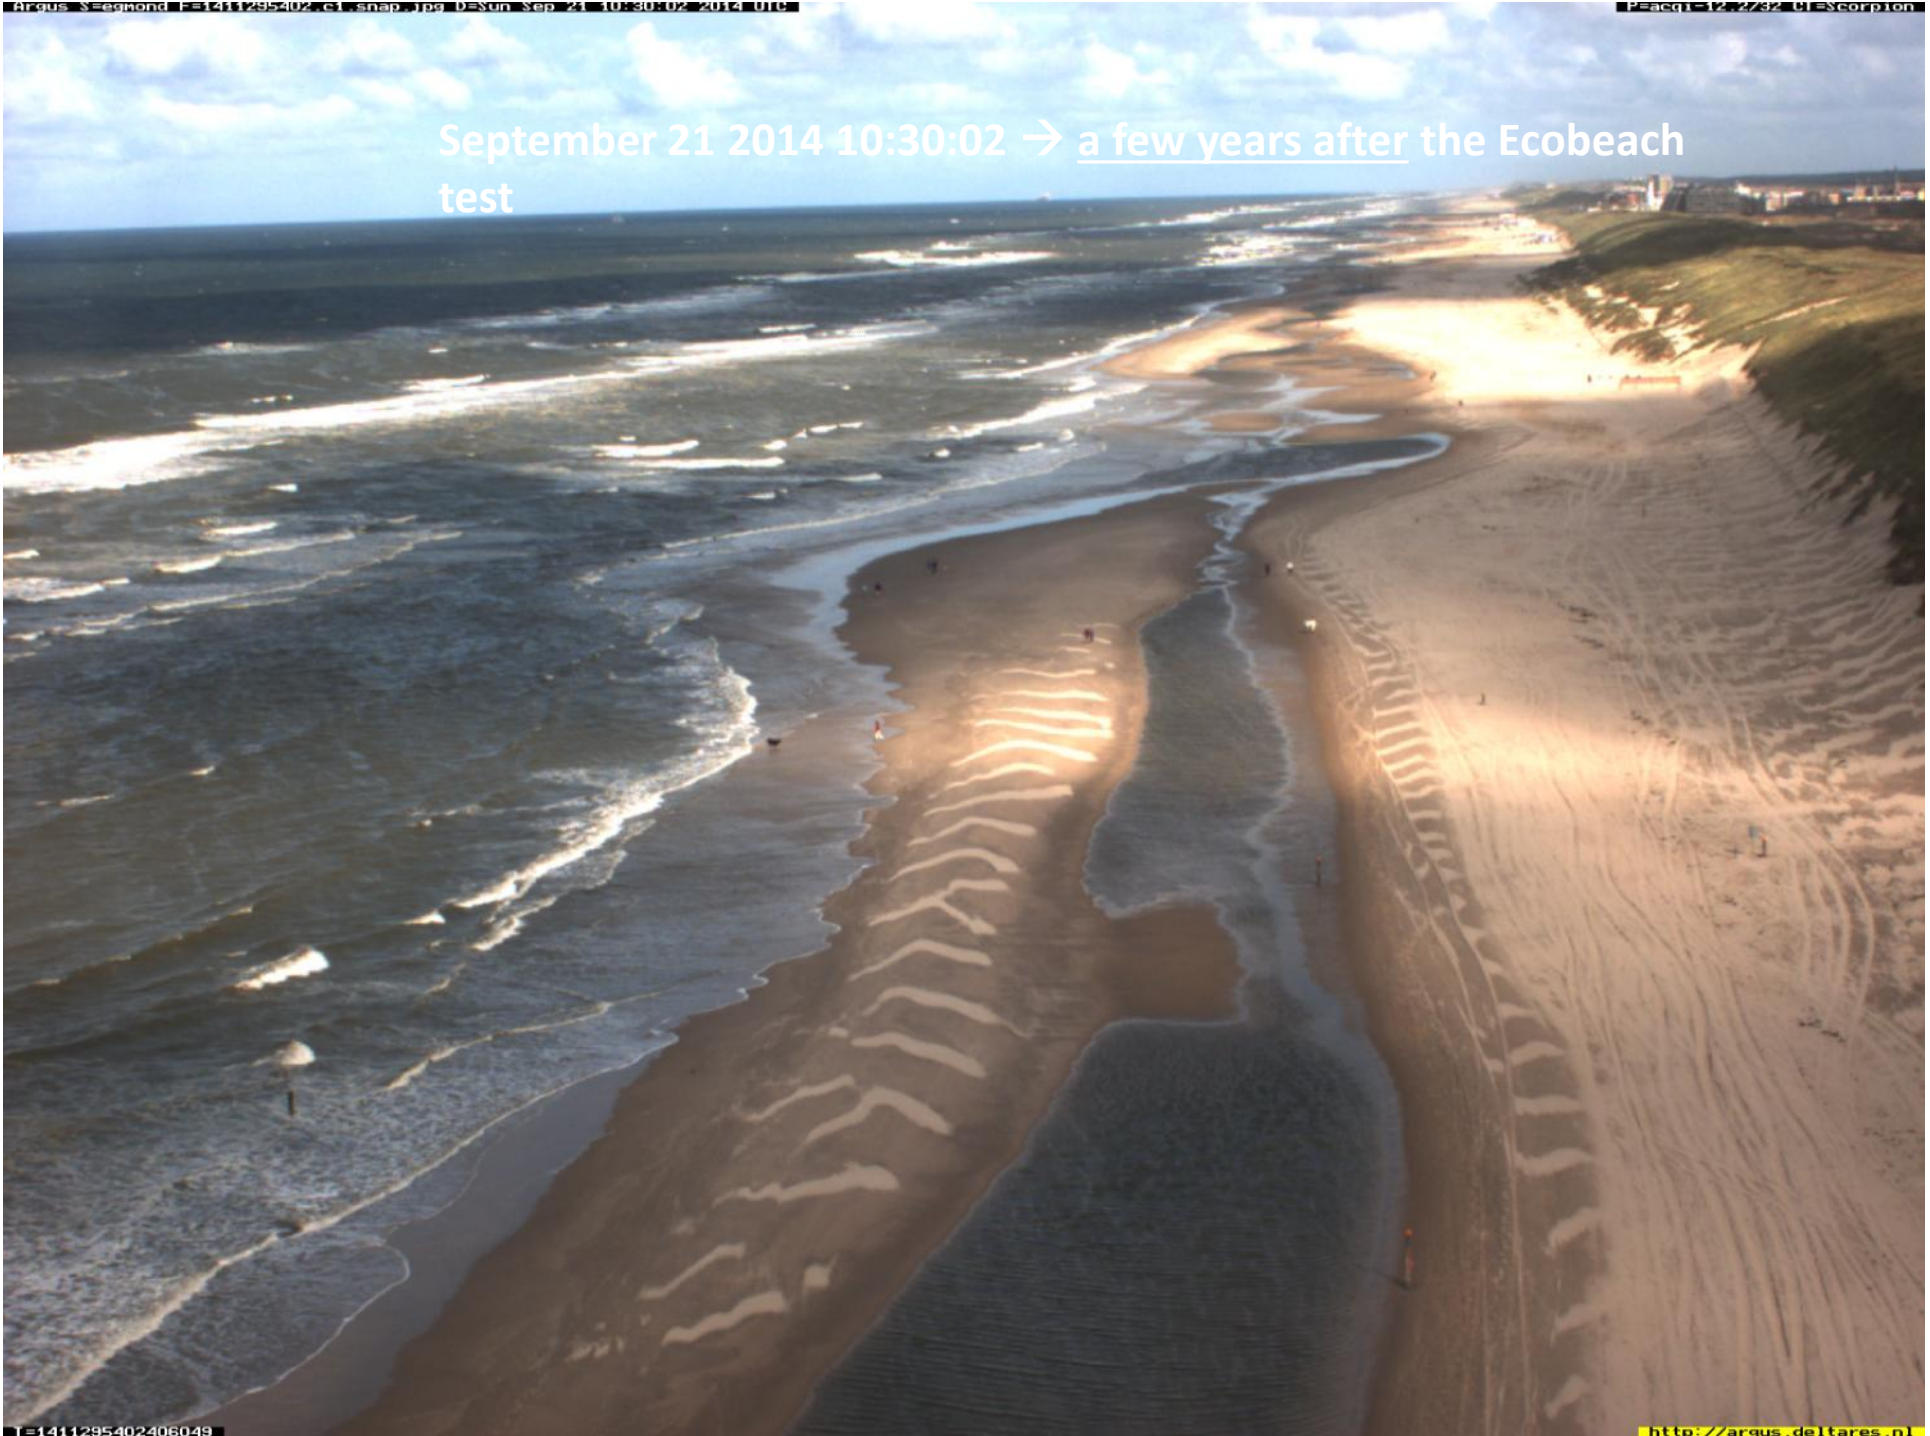
September 21 2014 10:30:02 → a few years after the Ecobeach test

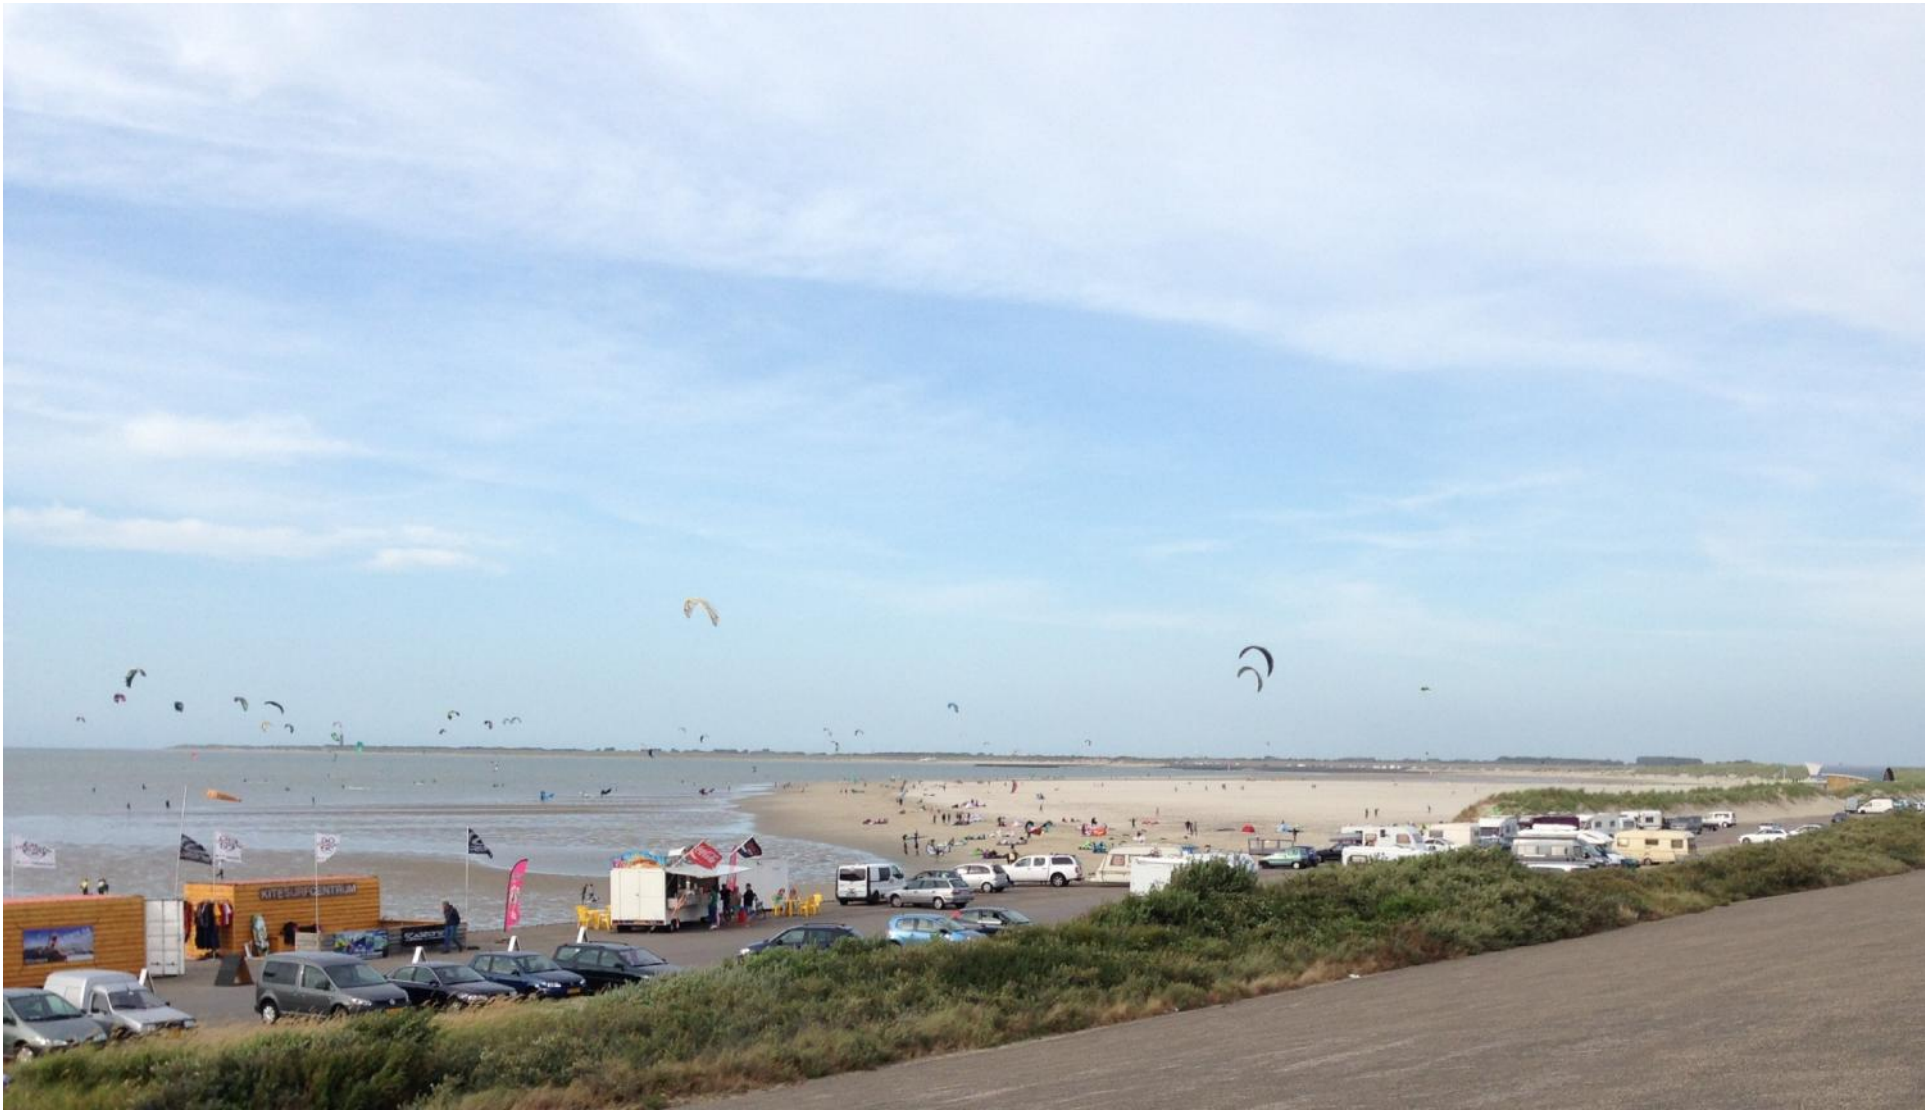
- Low and wide beach against a dam with an asphalt revetment
 - Beach “moves” toward the North
 - Significant erosion at the South-West area
 - Some accretion at the North-East area
 - Beach surface area decreases
 - Too little space for beach activities
-
- Nourishment of 400.000 to 500.000 m³ is planned for 2015
 - Recovering beach surface area to the situation of 2003

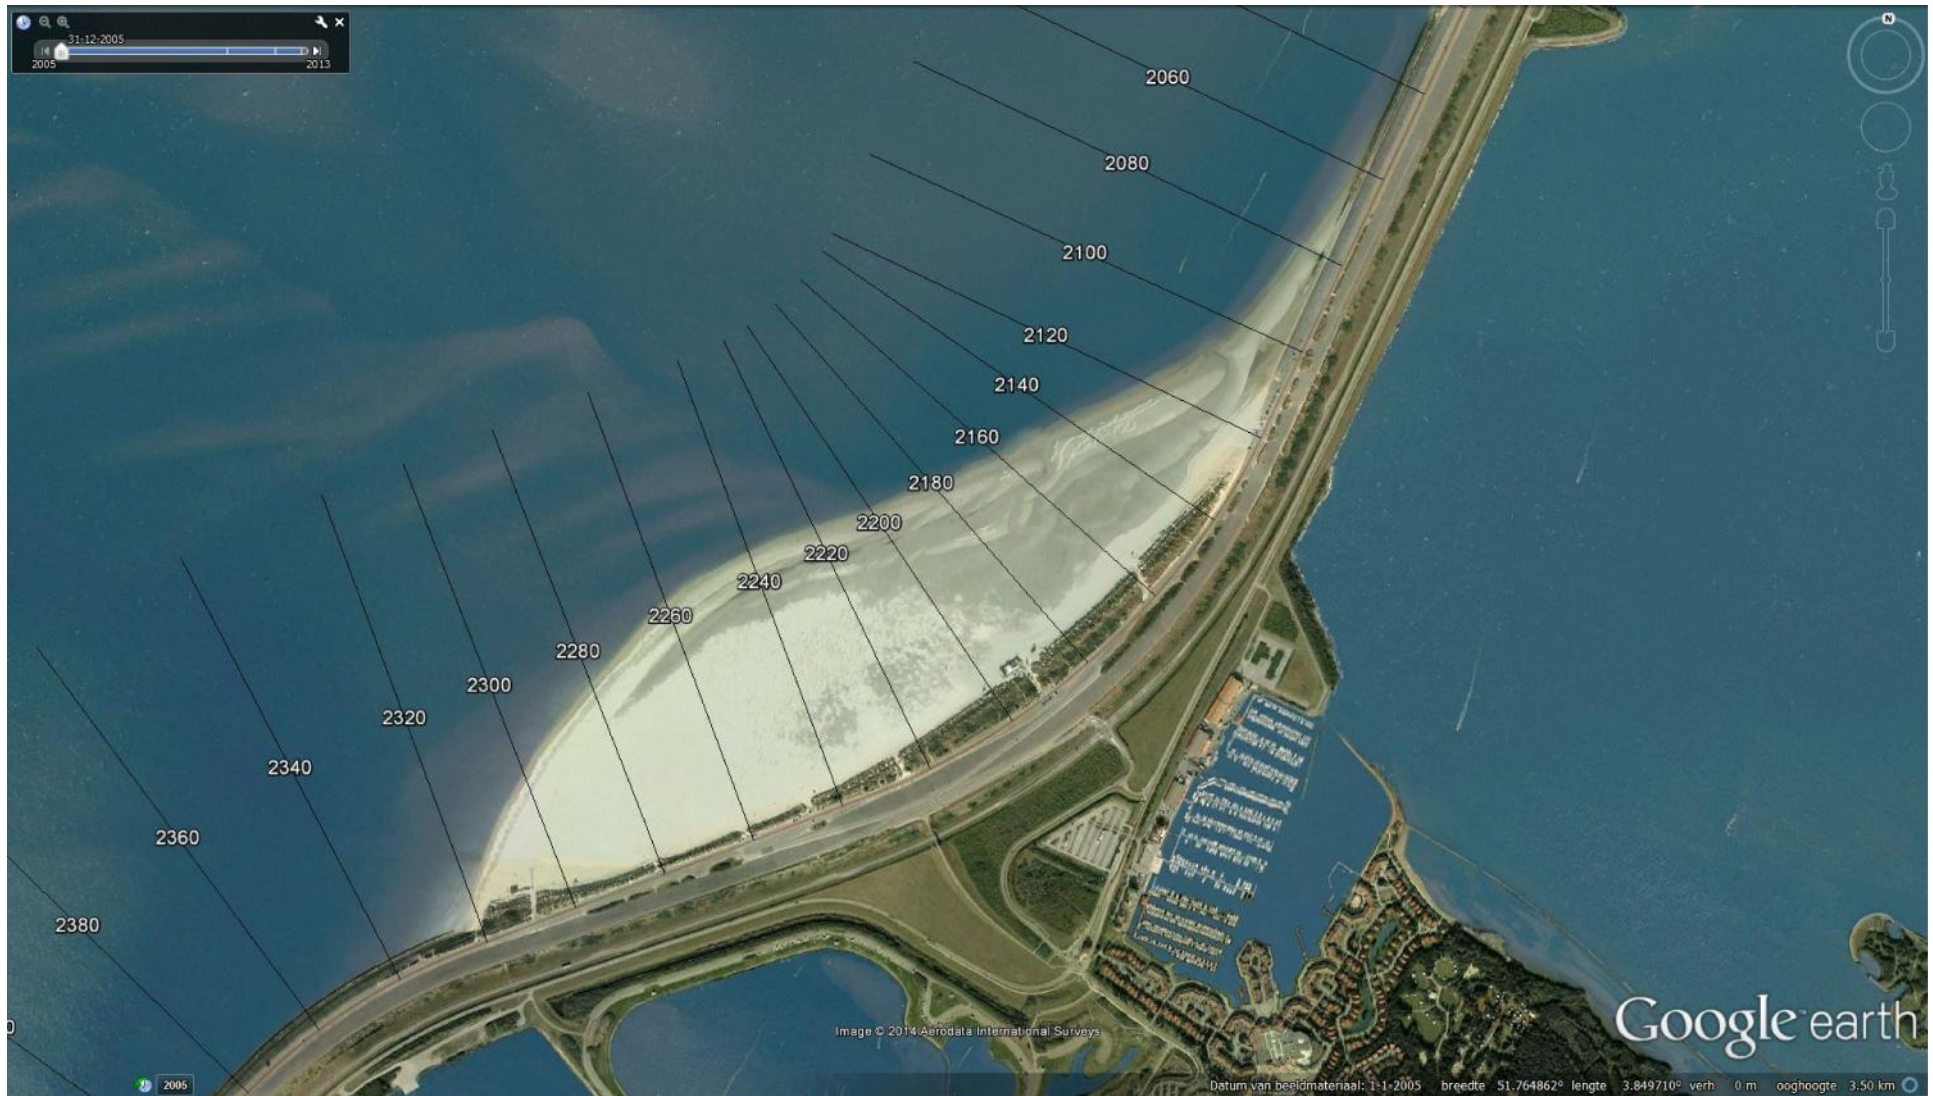
Brouwersdam in 2013
