Ecobeach

A sustainable beach by drainage

Brouwersdam, 3-10-2014

Head of Coastal Department BAM Infraconsult

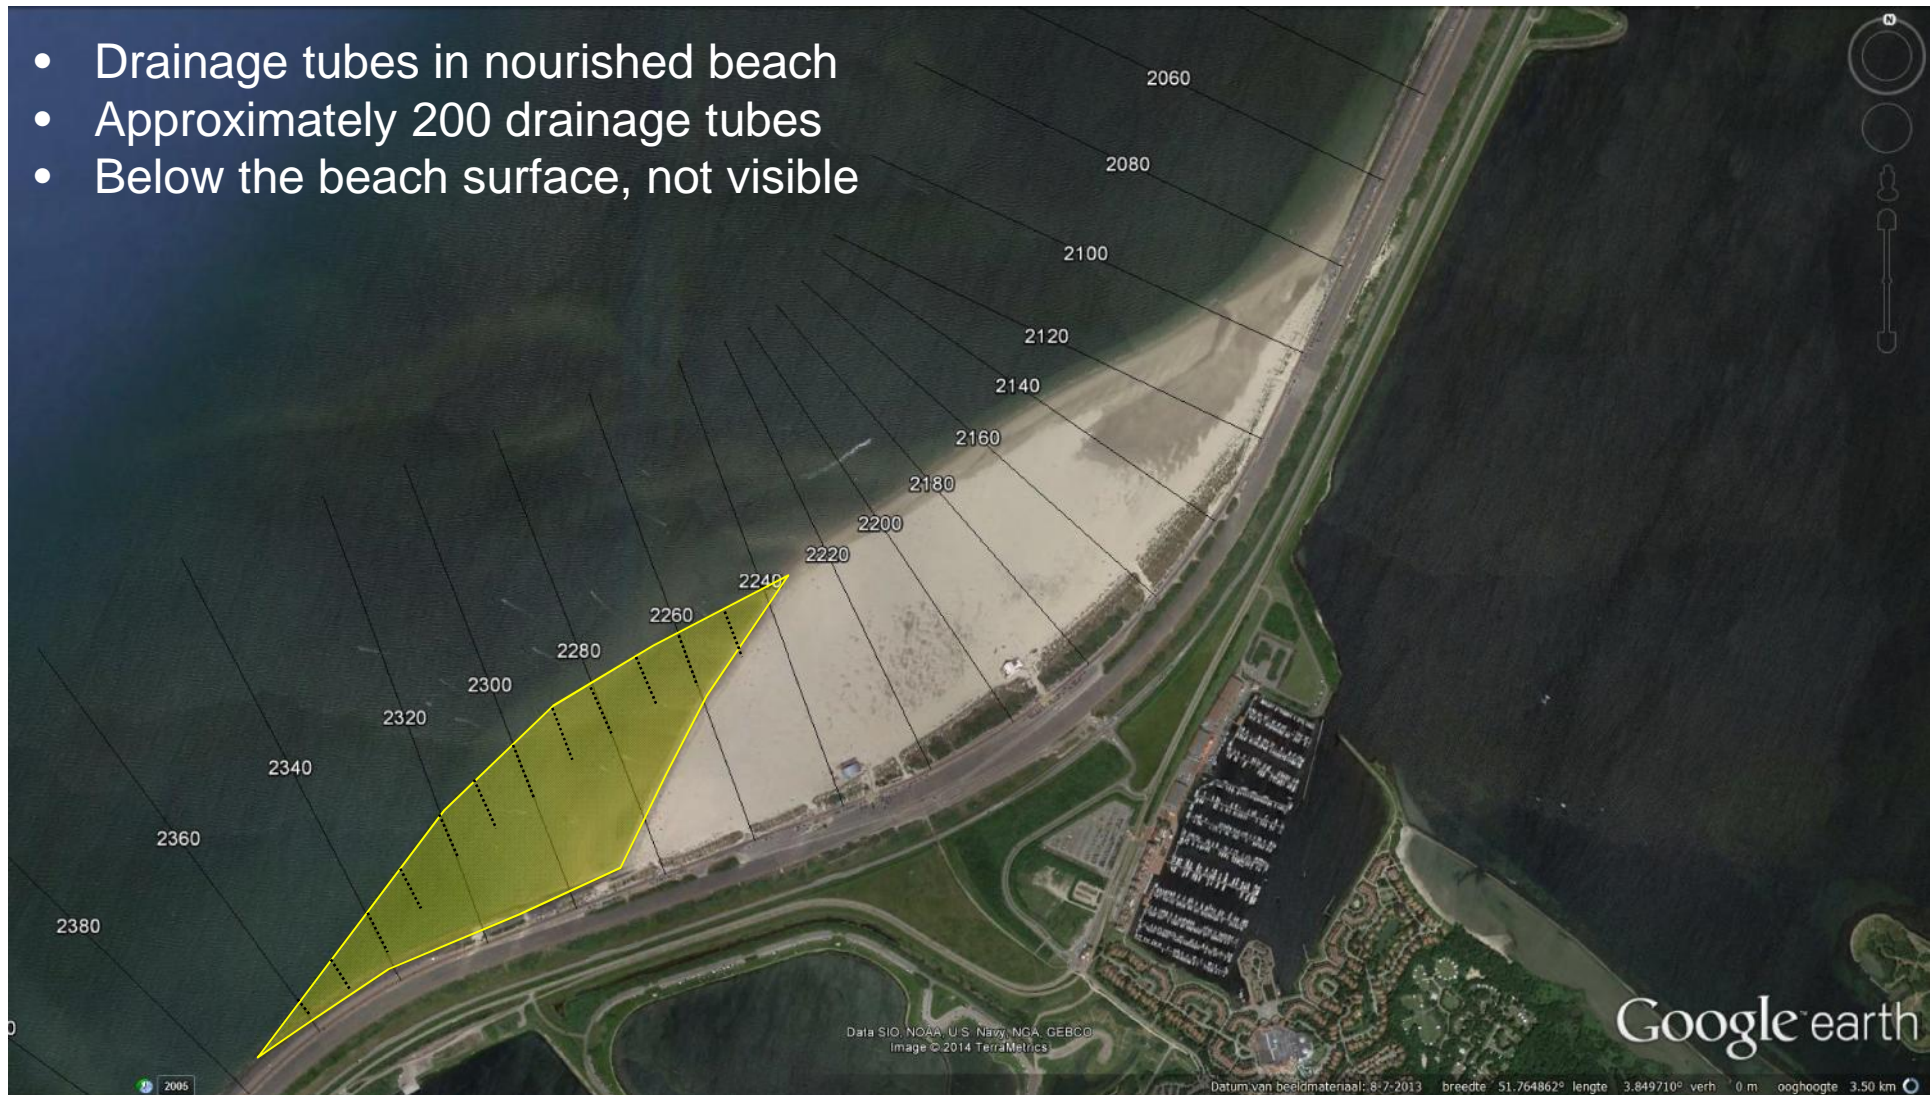
Possible configuration of Ecobeach

- Drainage tubes in nourished beach
- Approximately 200 drainage tubes
- Below the beach surface, not visible

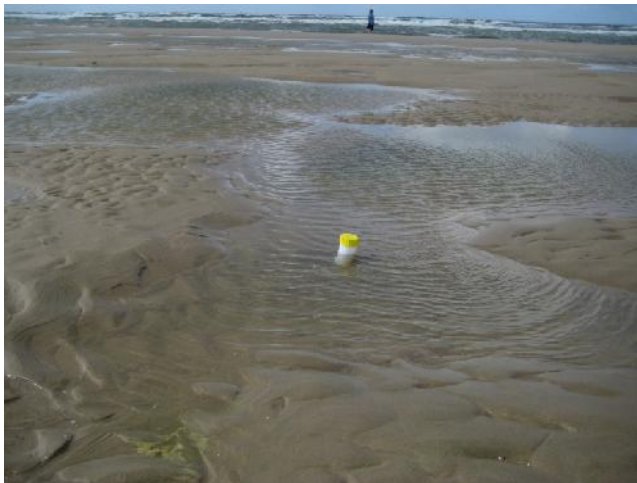
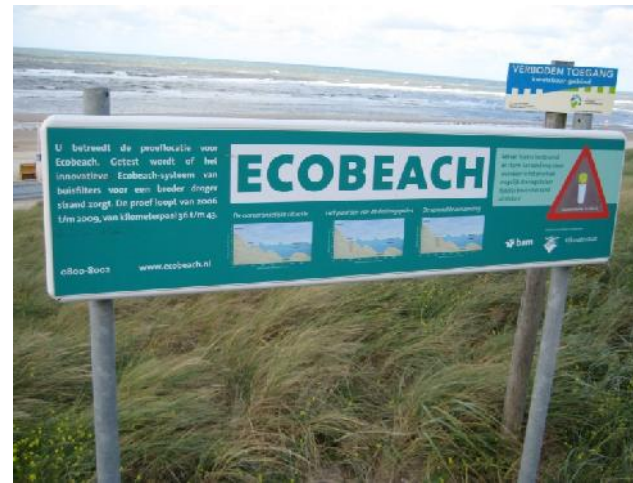
Maintenance of Ecobeach

- Passive system, so limited maintenance necessary
- Drainage tubes are made of polyethylene, so not fragile
- After a storm some tubes can protrude the beach surface, usually around the low water line (yellow cap)
- This was reported by beach restaurant owners/coast guard in Egmond
- These tubes are injected up to 25 cm below the beach surface (2 men and a pump)
- Maintenance decreases with time
